**Hemmera Envirochem Inc.**

**Re: William and Nancy Phillips Restoration Project - Effectiveness Monitoring Report**

## **Nancy Phillips Slough Photo Documentation**

### **William Phillips Slough Photo Documentation**

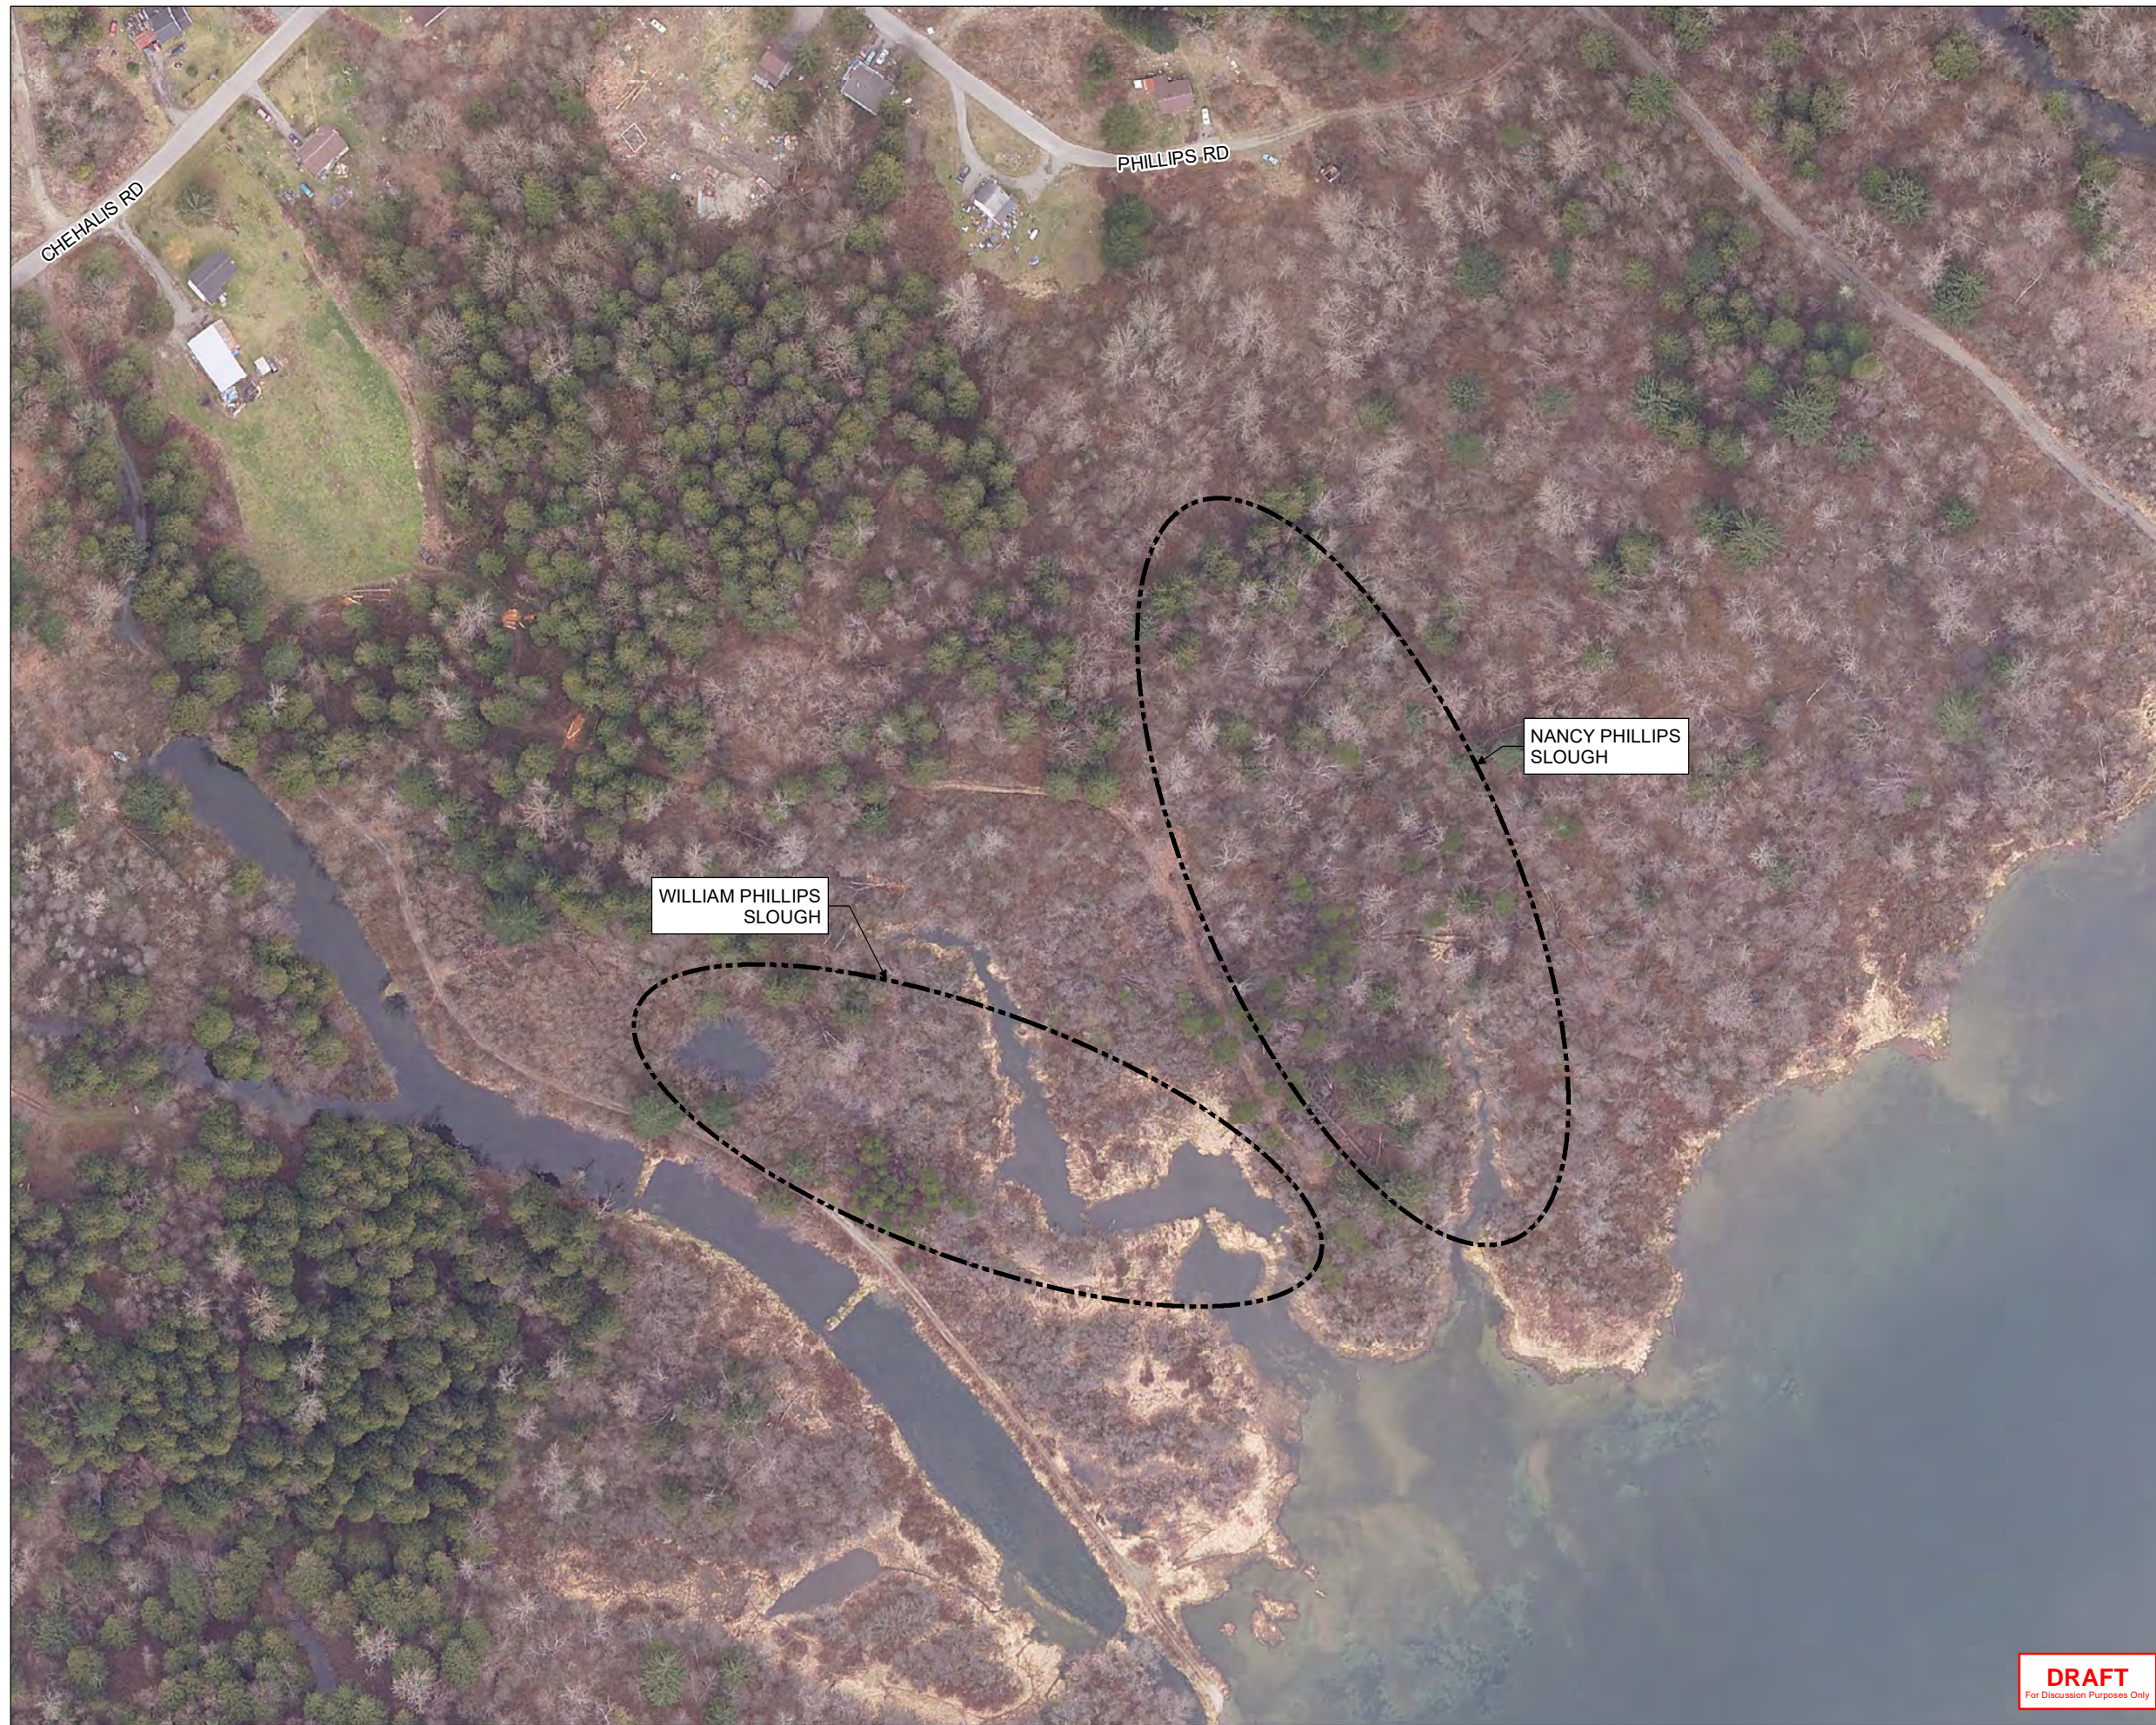
William and Nancy Phillips  
Slough Restoration Project

Location and Pre-construction Condition of  
Nancy and William Phillips Slough

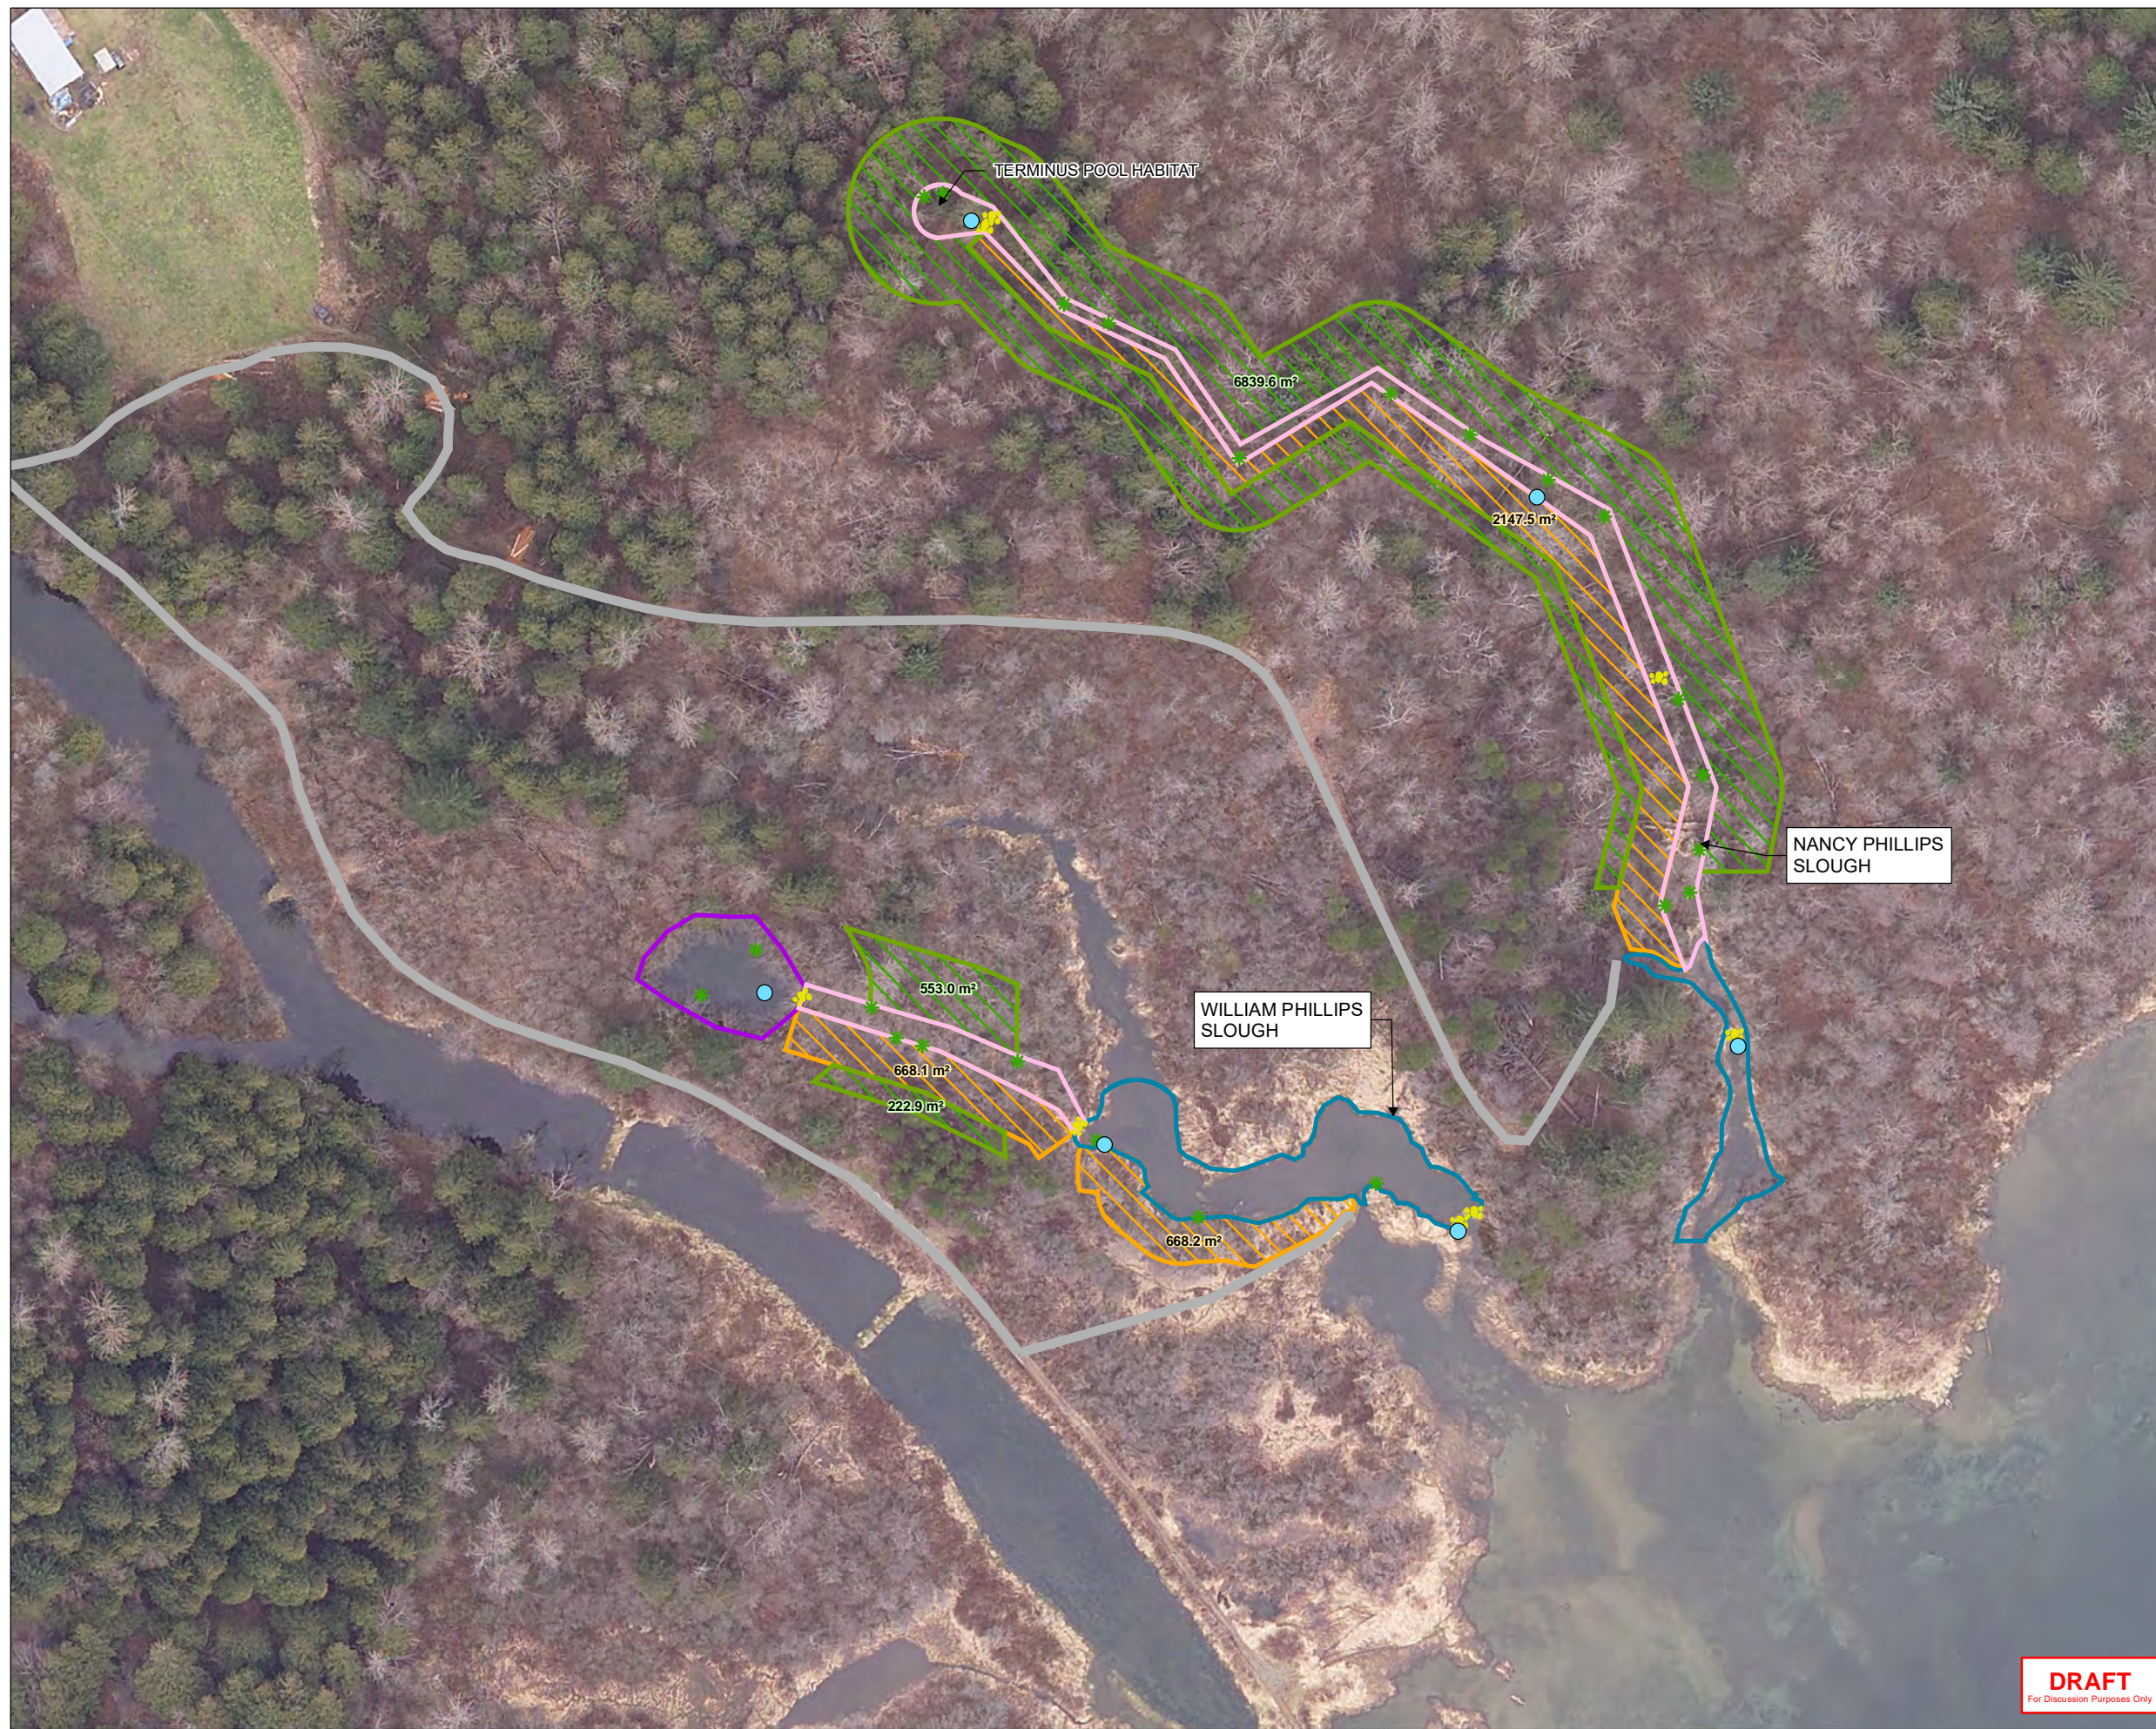
**William and Nancy Phillips Slough  
As-built Drawing**

Spring Monitoring Event *in-situ* water quality data for Nancy Phillips and William Phillips sloughs is presented in **Table 1**; water quality sampling locations are presented in **Figure 1**. Water quality temperature measured in both sloughs was within an acceptable range to support over-wintering and rearing habitat for juvenile salmonids. DO levels were generally slightly below optimal levels for over-wintering; however, within the optimal range for juvenile salmonid rearing in both sloughs. The pH levels were below optimal levels; however, low pH is consistent with long-term monitoring data collected for Harrison Slough habitats. Water quality data was collected by Pearson Ecological as part of slough monitoring over the period from September 19, 2017 to September 17, 2019 and indicated temperature data over the period from November 2018 to September 2019 ranged between 3.4 – 13.1 °C (n= 3,663), pH levels ranged between 6.2 – 6.9 (during mid-late summer sampling; n= 41), specific conductivity ranged from 42 – 61 uS (during mid-late summer sampling; n=41), and turbidity was <5 NTU (n= 7; mid-late summer sampling). Pearson Ecological collected spot measurements in Frank Dan Slough in November 2017, April 2018, October 2018, and April 2019 (**Appendix C**). Temperature and conductivity levels measured in Nancy Phillips and William Phillips sloughs were generally consistent with the data collect for Frank Dan Slough. The pH levels for the Project sloughs were lower than pH levels recorded in nearby Frank Dan Slough in April 2018/2019 (Frank Dan Slough pH Range = 6.4 – 6.9); the DO levels in the Project sloughs were also lower than those recorded in Frank Dan Slough in April 2019 (Frank Dan Slough DO = 8.16 – 12.06 mg/L).

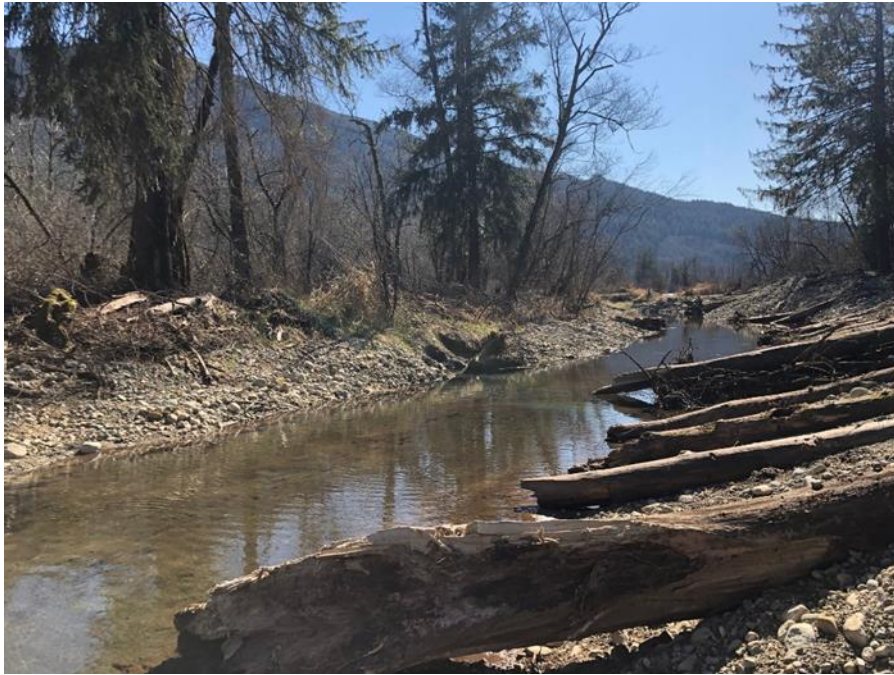
**Photo 1** Looking south along Nancy Phillips west bank at typical new channel construction conditions; large woody debris placement installed (March 16, 2020).

Visual assessments of slough channel stability in Nancy Phillips Slough during the Spring Monitoring Event did not note any channel instability concerns. The newly constructed channel and restored/enhanced channel sections were stable and no disturbance indicators (i.e., slumping) were observed. Representative channel bank conditions are shown in **Appendix A - Photo 1** and **2**. Riparian vegetation along the east bank of Nancy Phillips Slough is generally intact (**Appendix A; Photo 3**); however, riparian vegetation along the west bank was impacted by side-cast material during channel excavation construction and equipment access along this bank (**Appendix A; Photo 4**). Channel substrates were dominated by a layer of fines; cobble/gravel substrates were dominant underneath the fines and along restored/enhanced slough habitat areas (**Appendix A; Photo 5**). Large woody debris structures within and along the channel banks and were observed to be functional (**Appendix A; Photo 6**).

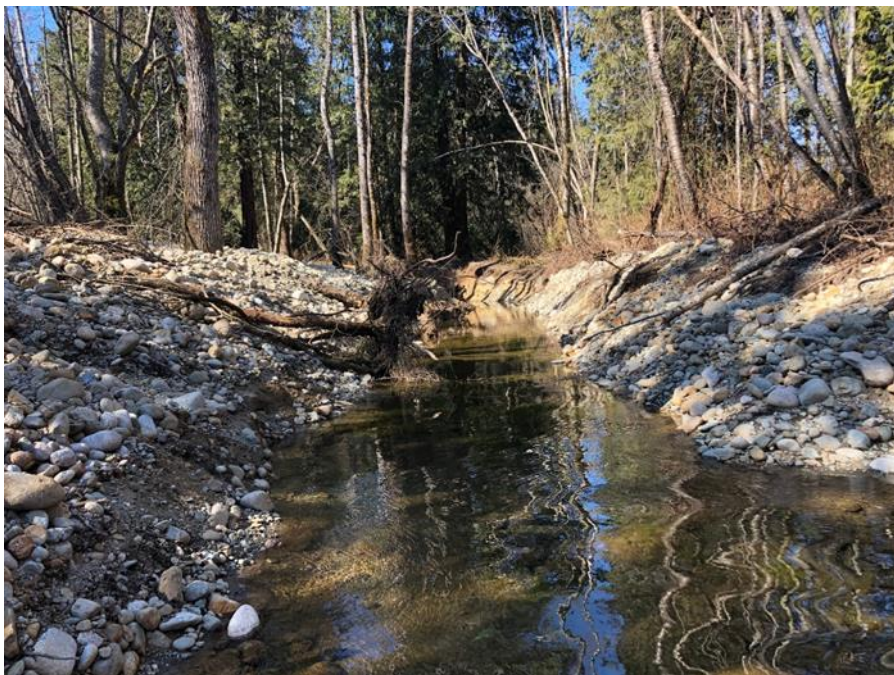
**Photo 2** Looking north along the new constructed channel of Nancy Phillips Slough at typical bank conditions (March 16, 2020).

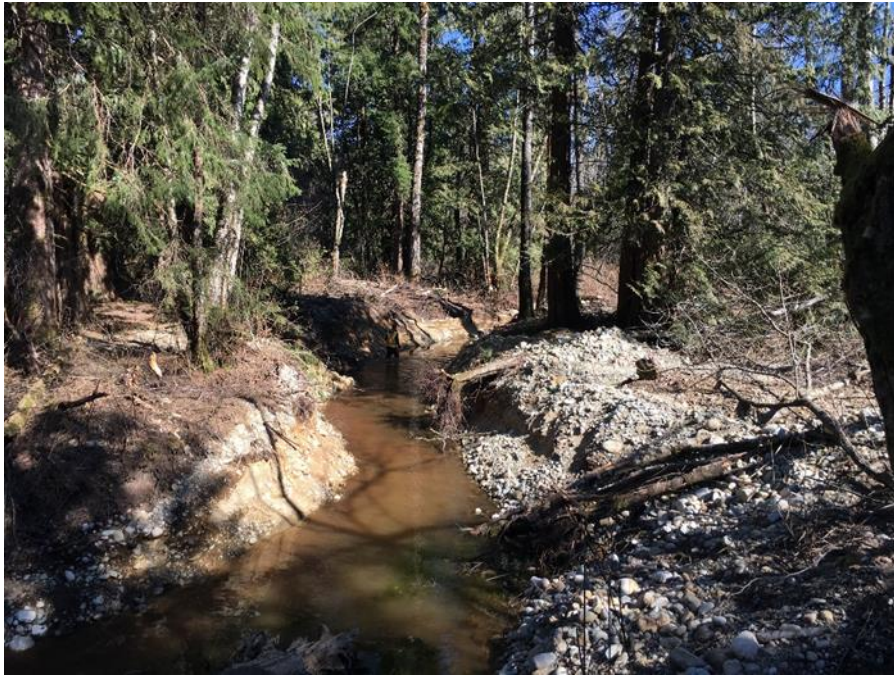
**Photo 3** Nancy Phillips Slough east bank riparian vegetation primarily intact; west bank riparian vegetation less intact (March 16, 2020).

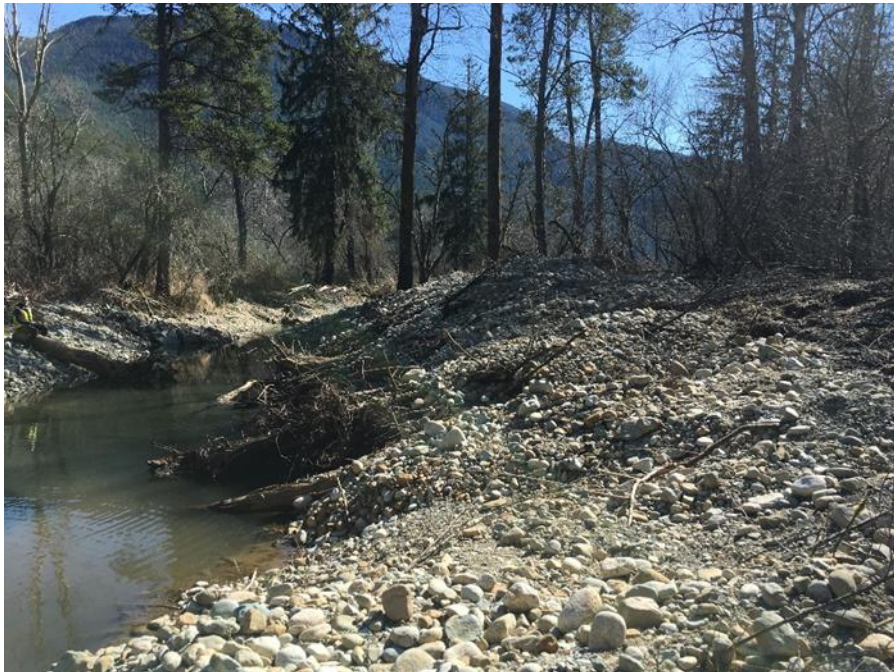
**Photo 4** Looking south along the west bank of Nancy Phillips Slough; typical riparian vegetation conditions (March 16, 2020).

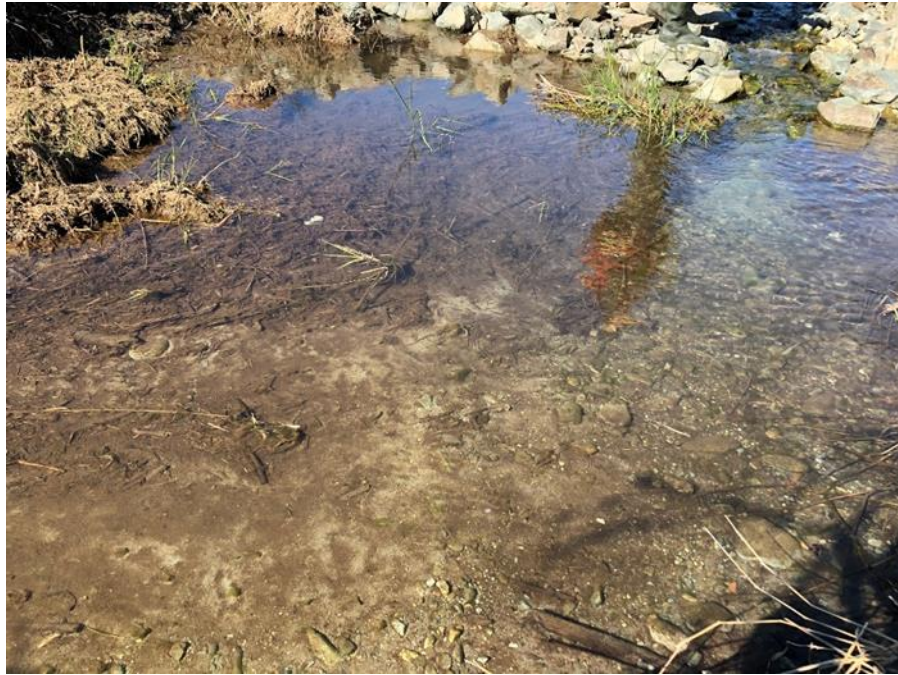
**Photo 5** Typical substrate conditions below Nancy Phillips Slough Weir 1A (March 16, 2020).

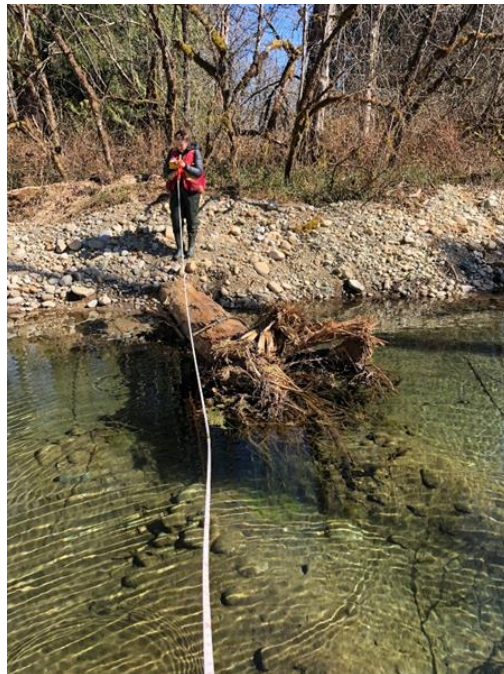
**Photo 6** Large woody debris structure installed in Nancy Phillips Slough and functional (March 16, 2020).

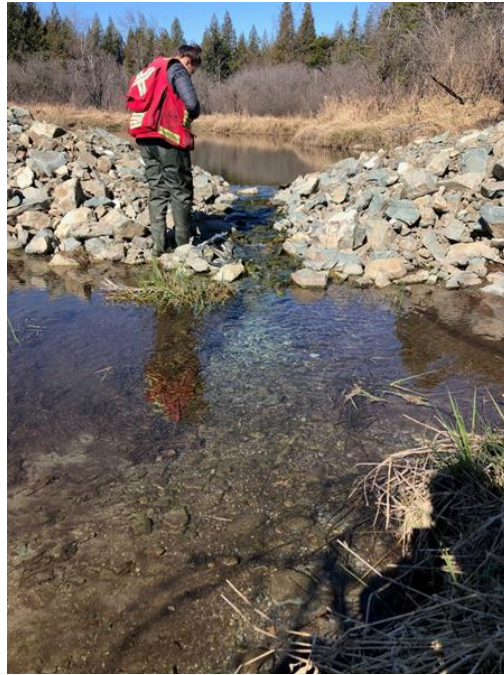
There are three constructed weirs along Nancy Phillips Slough (Weir 1A – Weir 3A). Weir 1A is the southernmost weir structure and is located immediately upstream of the slough’s confluence with the Harrison River. Water flowing over Weir 1A was 0.09 m deep and connected surface flow was observed between the upstream pool and the downstream channel; Weir 1A was determined to be fish passable at the time of assessment (**Appendix A; Photo 7**). Weir 2A is located approximately 80 m upstream (north) from Weir 1A. Water flowing over Weir 2A was 0.09 m deep and connected surface flow was observed over this weir weir; Weir 2A was assessed as fish passable (**Appendix A; Photo 8**). Weir 3A is located at the outlet of the Upper Terminus Pool at the northern extent of Nancy Phillips Slough. Water flowing over Weir 3 was 0.10 m deep and connected surface flow was observed over this weir structure. Weir 3A was determined to be fish passable at the time of assessment.

**Photo 7** Looking north at Nancy Phillips Slough Weir 1A closest to the Harrison River confluence (March 16, 2020).

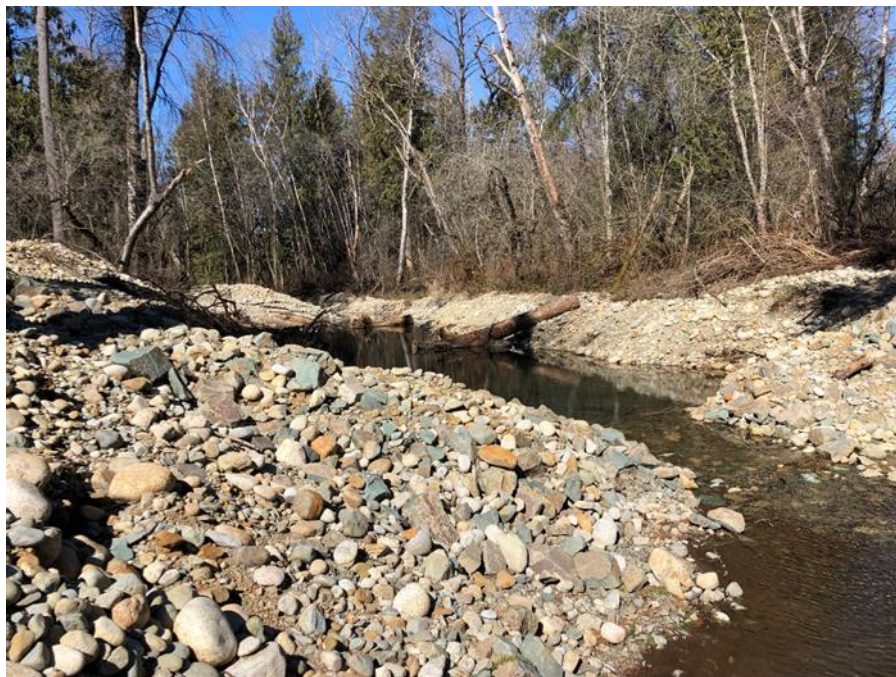
**Photo 8** Looking north from Nancy Phillips west bank at Weir 2A (March 16, 2020).

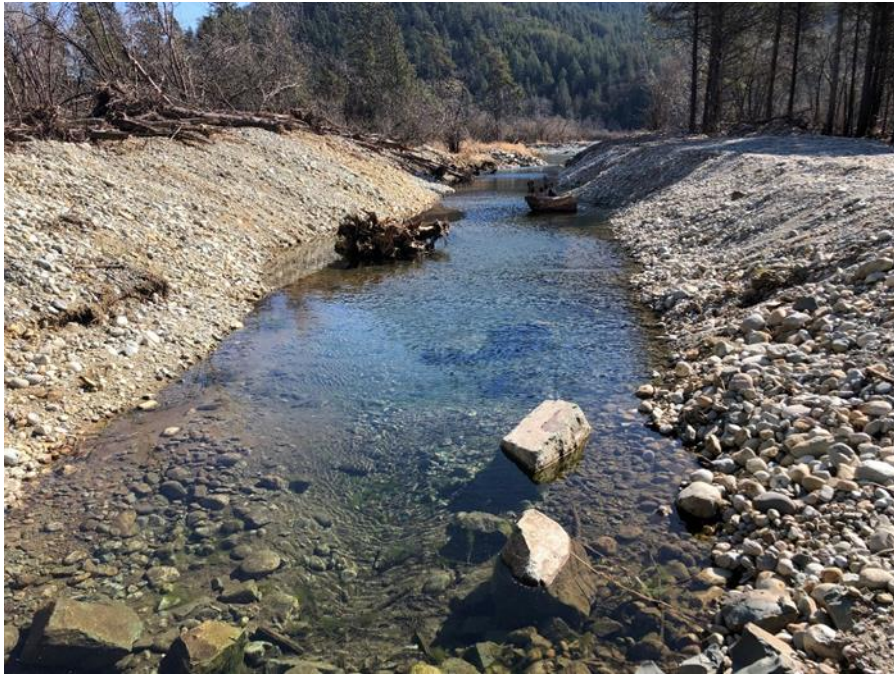
**Photo 1** Looking south along William Phillips at typical new channel construction conditions; large woody debris placement installed (March 16, 2020).

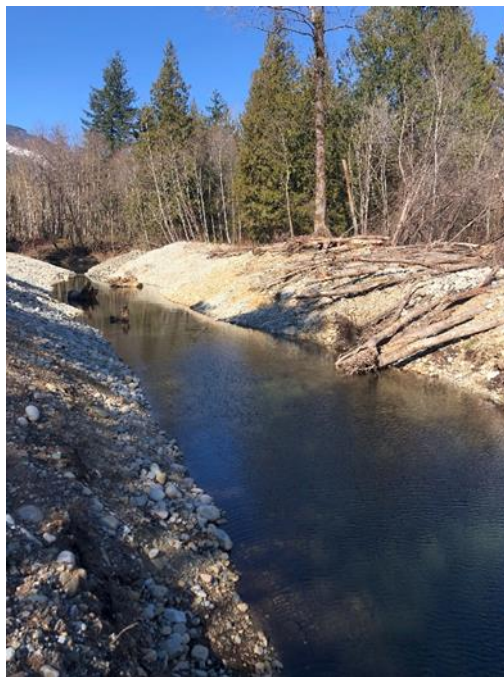
**Photo 2** Looking north along the new constructed channel of William Phillips Slough at typical bank conditions (March 16, 2020).

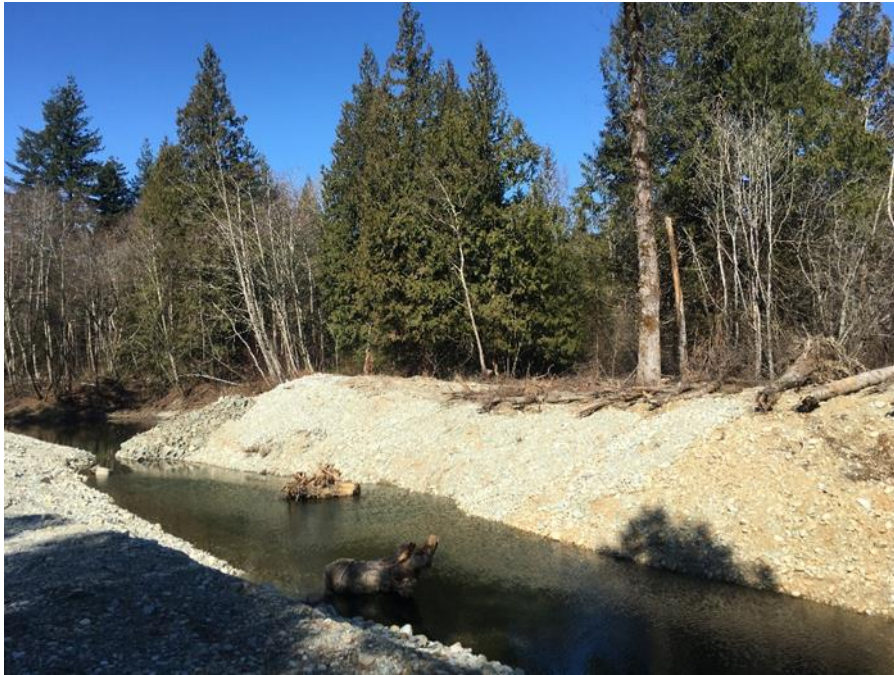
**Photo 3** William Phillips Slough east bank riparian vegetation primarily intact (March 16, 2020).

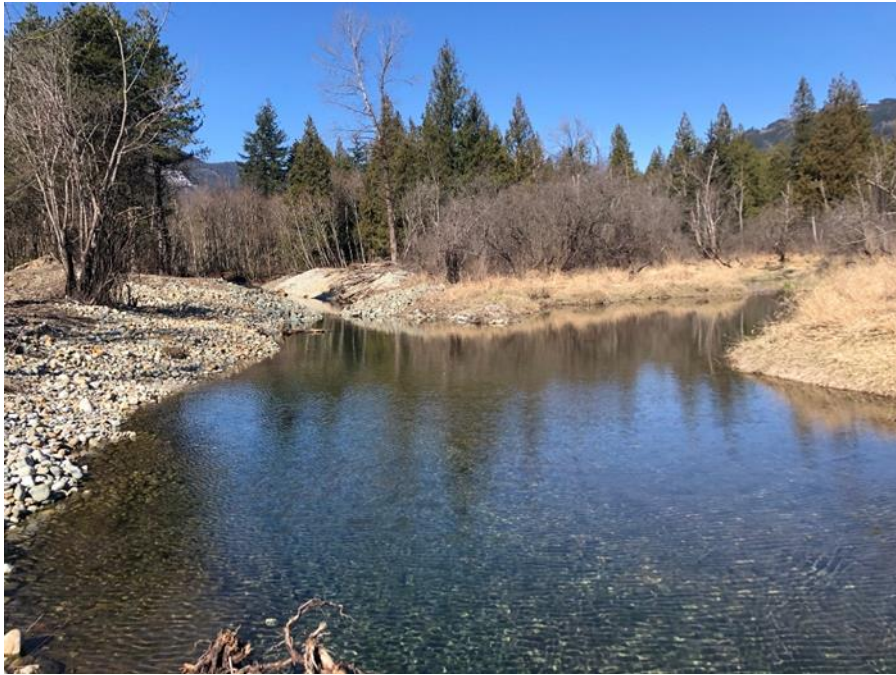
**Photo 5** Typical substrate conditions below William Phillips Slough Channel Fork (March 16, 2020).

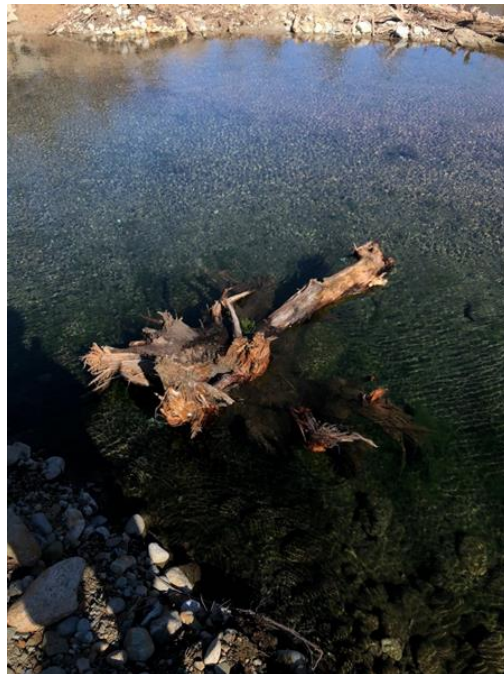
Visual assessments of channel stability in William Phillips Slough during the Spring Monitoring Event did not find any channel instability concerns. The newly constructed channel and restored/enhanced channel sections were stable and no disturbance indicators (i.e., slumping) were observed. Representative channel bank conditions are shown in **Appendix B; Photo 1** and **2**. Riparian vegetation along the newly constructed east bank of William Phillips Slough is primarily intact (**Appendix B; Photo 3**); however, riparian vegetation along the west bank was impacted by the side-cast of material during channel excavation construction (**Appendix B; Photo 4**). Channel substrates were dominated by a layer of fines; however predominantly characterized by cobble/gravels underneath the accumulated fine material (**Appendix B; Photo 5**). Large woody debris structures within and along the channel banks and were observed to be functional (**Appendix B; Photo 6**).

**Photo 6** Large woody debris structure installed in William Phillips Slough and functional (March 16, 2020).

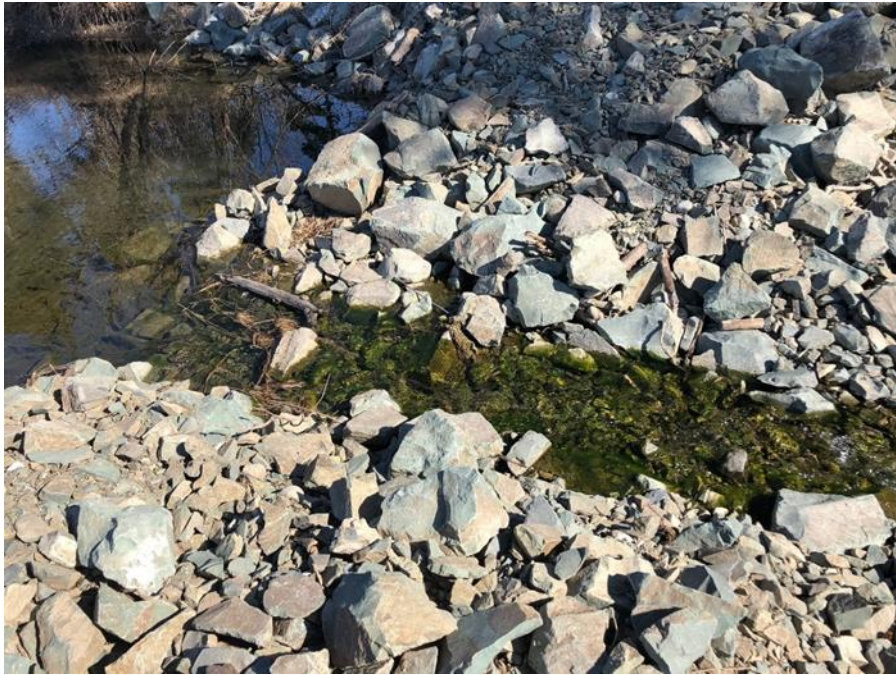
There are three constructed weirs along William Phillips Slough (Weir 1B – Weir 3B). Weir 1B is the southernmost weir structure and is located immediately upstream of the slough's confluence with the Harrison River. Water flowing over Weir 1B was 0.11 m deep and connected surface flow was observed over the length of this structure; Weir 1B was assessed as fish passable (**Appendix B; Photo 7**). Weir 2B is located at the channel fork of William Phillips Slough. Water flowing over Weir 2B was 0.15 m deep and connected surface flow was observed over this structure; Weir 2B was assessed as fish passable (**Appendix B; Photo 8**). Weir 3B is at the outlet of the pond habitat at the northern extent of William Phillips Slough. Water flowing over Weir 3B was 0.08 m deep and connected surface flow was observed over this structure. Weir 3B was determined to be fish passable at the time of assessment (**Appendix B; Photo 9**).

**Photo 7** Looking north at William Phillips Slough Weir 1B closest to the Harrison River confluence (March 16, 2020).

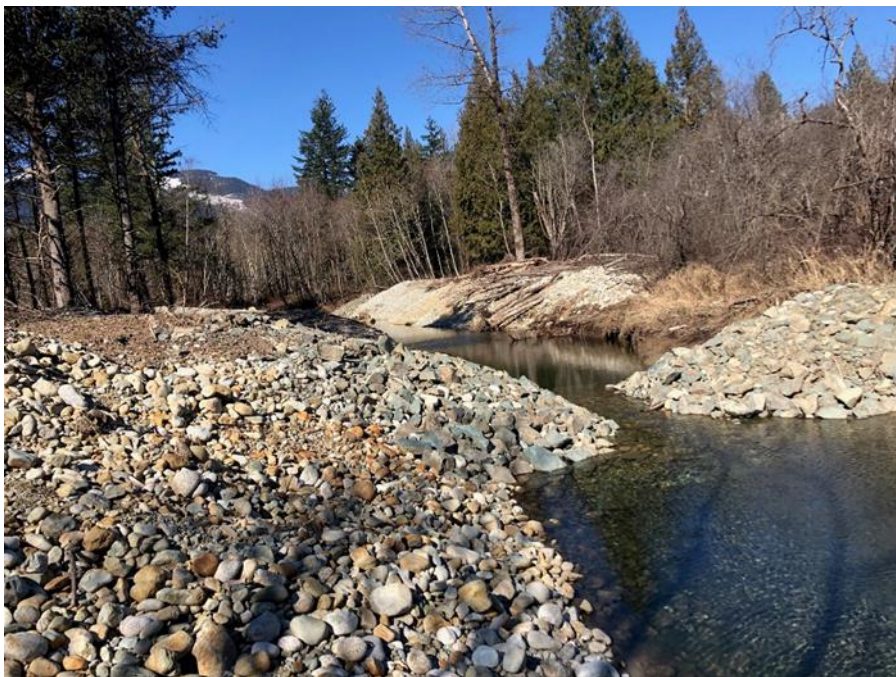
**Photo 8** Looking north at William Phillips Slough Weir 2B (March 16, 2020).

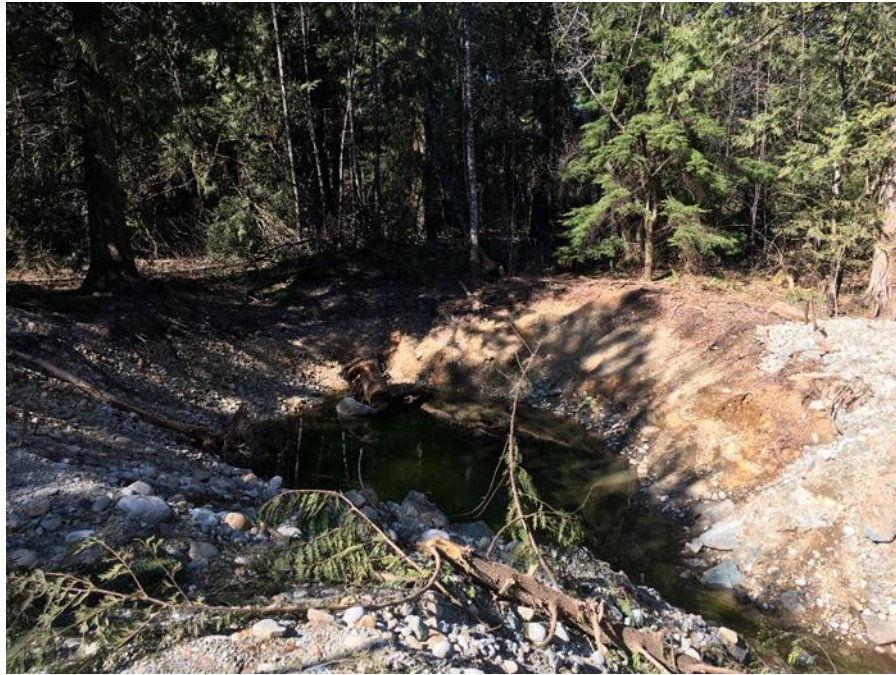
**Photo 9** Looking north at William Phillips Slough Weir 3B (March 16, 2020).
