**Re: Planting Plan for Williams Phillips and Nancy Phillips Sloughs**

**William and Nancy Phillips Slough  
As-built Drawing**

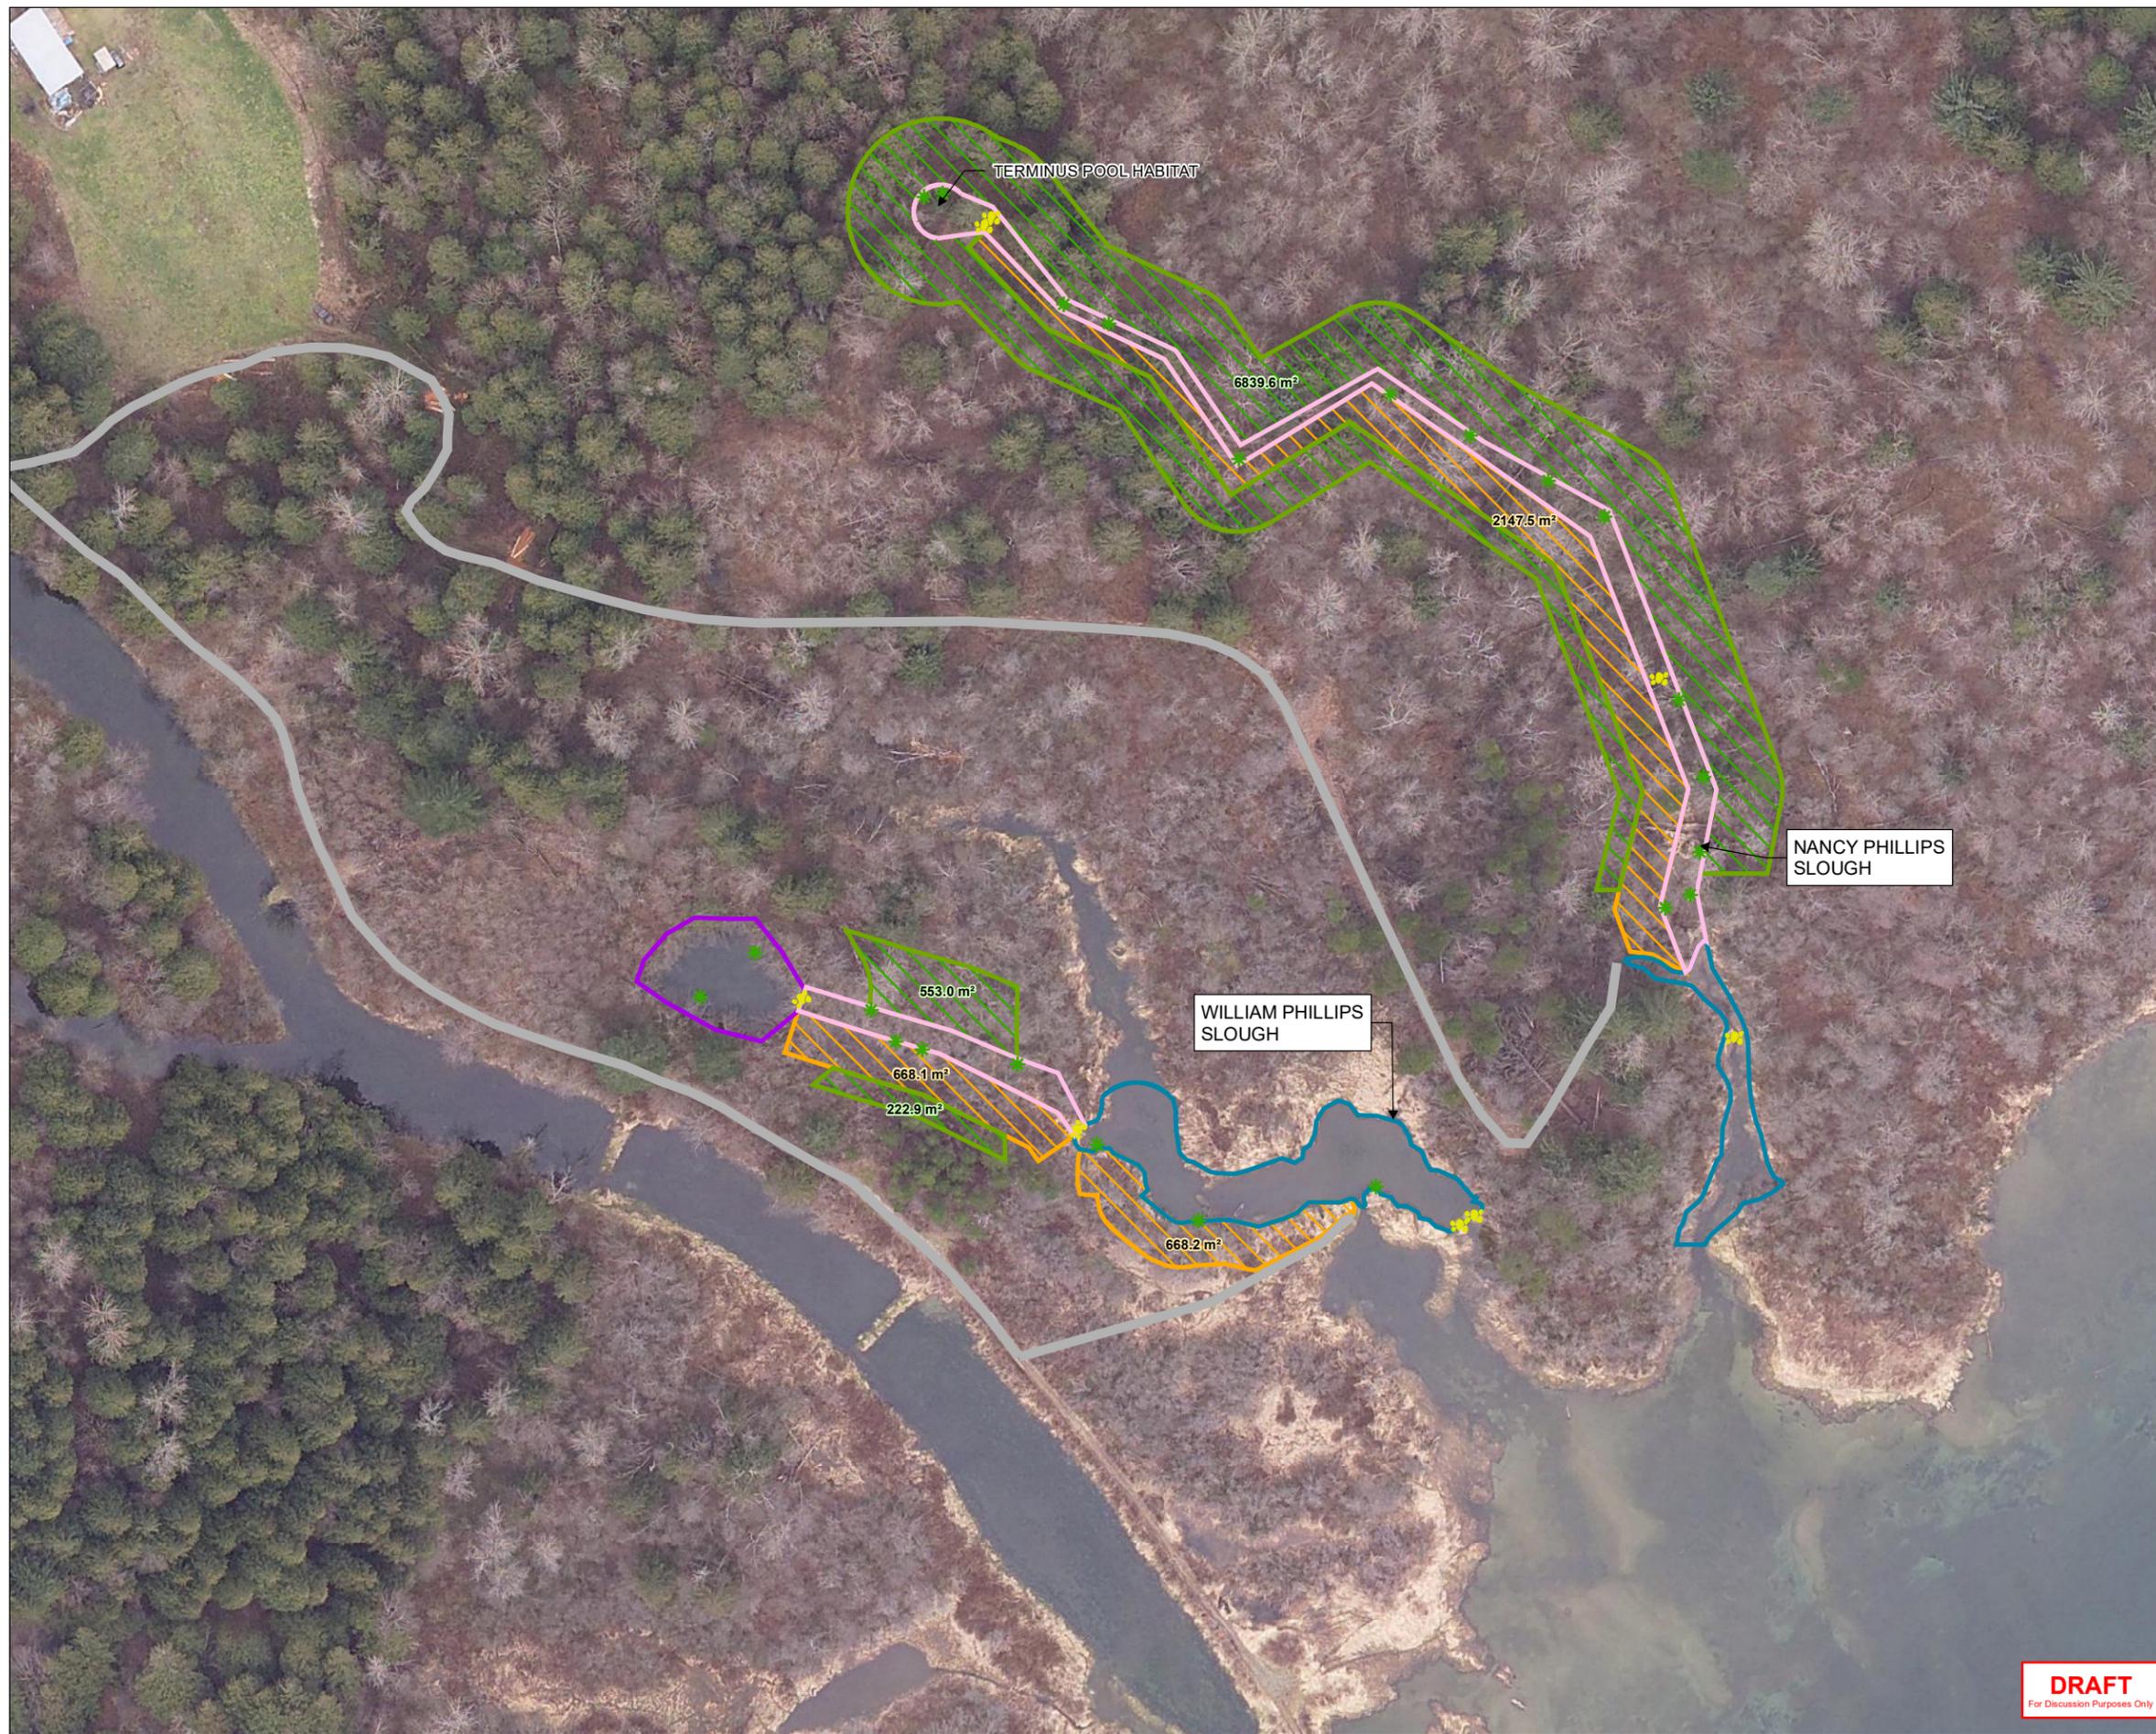
- Rock Weir
- Large Woody Debris
- Access Road
- Existing (Approximate Area: 1,946 m<sup>2</sup>)
- Enhance (Approximate Area: 726 m<sup>2</sup>)
- New (Approximate Total Area: 1,916 m<sup>2</sup>)
  - Nancy Phillips Slough Approximate Area: 1,486 m<sup>2</sup>
  - William Phillips Slough Approximate Area: 430 m<sup>2</sup>
- Riparian Planting (Approximate Area: 3,483 m<sup>2</sup>)
- New Riparian Area (Approximate Area: 7,615 m<sup>2</sup>)

During a site visit on March 16, 2020, two Hemmera biologists inspected the sloughs to assess the as-built condition and identify suitable locations for restoration planting. The candidate locations for restoration planting are specified in as-built drawings (**Appendix A**) and documented in the Photo Log (**Appendix B**). A total area of ~3,500 m<sup>2</sup> was identified for restoration planting at both sloughs; ~1,350 m<sup>2</sup> and ~2,150 m<sup>2</sup> at the William Phillips Slough and Nancy Phillips Slough, respectively.

There is a total of ~1,350 m<sup>2</sup> of riparian habitat at the William Phillips Slough that could be supplemented with riparian plantings to further enhance fish habitat values (see **Appendix A**). The adjacent riparian habitat at William Phillips Slough contains minimal canopy cover and extensive growth of reed canary grass (**Appendix B**); therefore, disturbed areas adjacent to the banks of the sloughs are providing minimal shade, food and nutrients inputs and have a lack of plant biodiversity. Given these factors, this area is a good candidate for riparian restoration associated with the project.

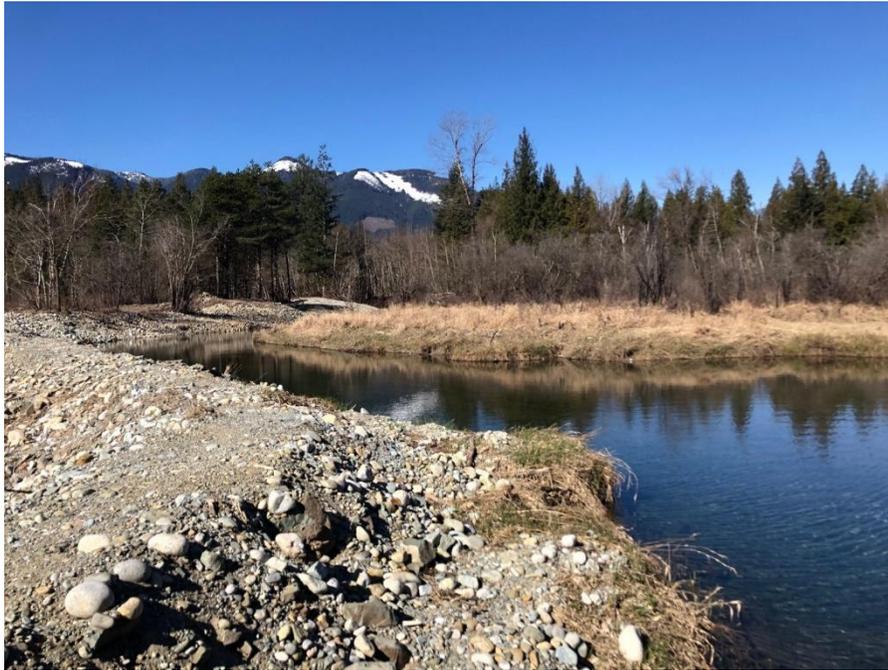
**Photo 1** March 16, 2020 – North facing view of riparian restoration area on William Phillips Slough (right bank)

The southern planting area identified on the William Phillips slough has existing topsoil that will support the growth of a variety of plant species. The northern planting area on William Phillips Slough is lacking topsoil and substrate consists mostly of cobble which would restrict growth potential for plantings.

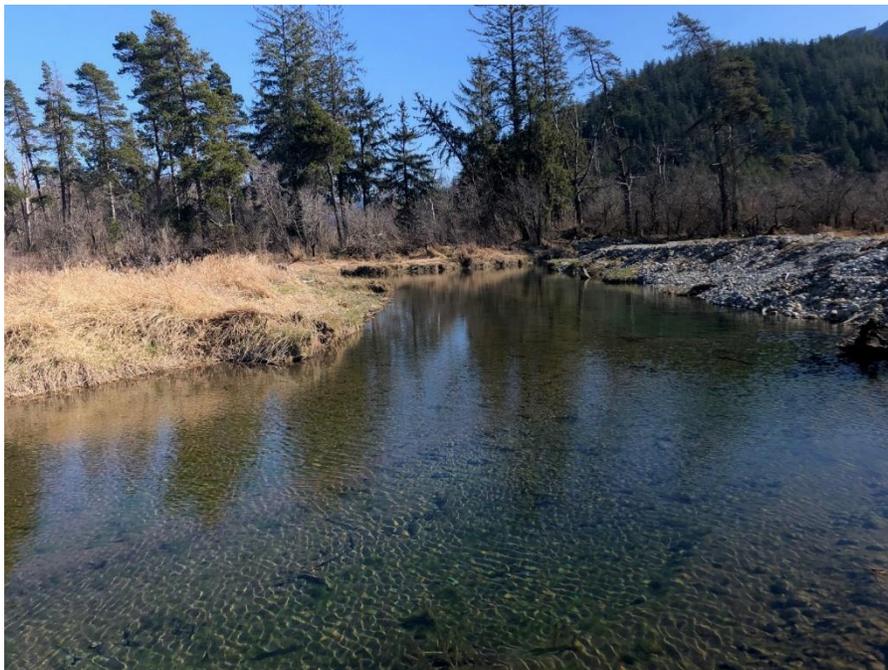
**Photo 2** March 16, 2020 – South facing view of riparian restoration area on William Phillips Slough (right bank)

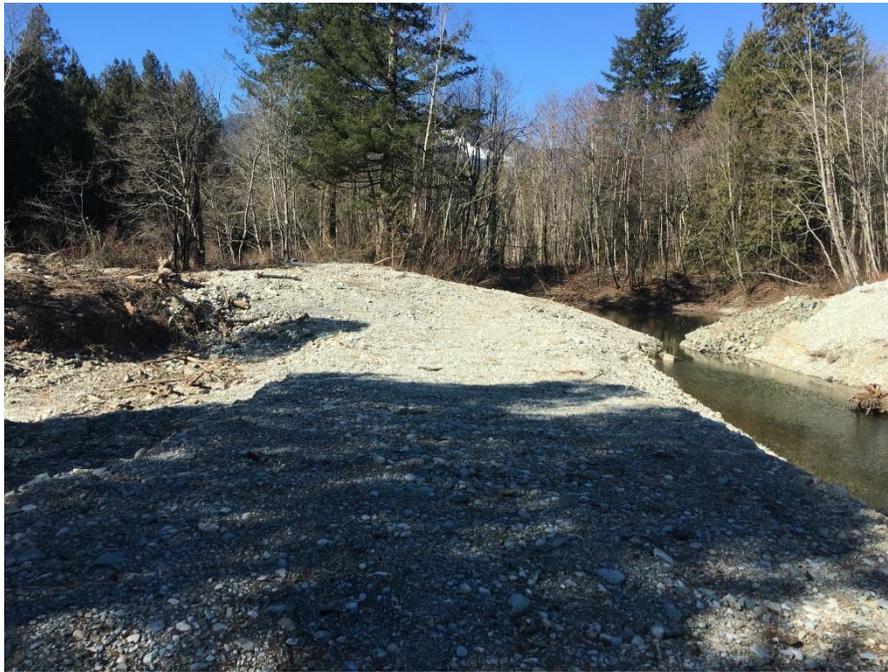
**Photo 3** March 16, 2020 – North facing view of riparian restoration area on William Phillips Slough (right bank).

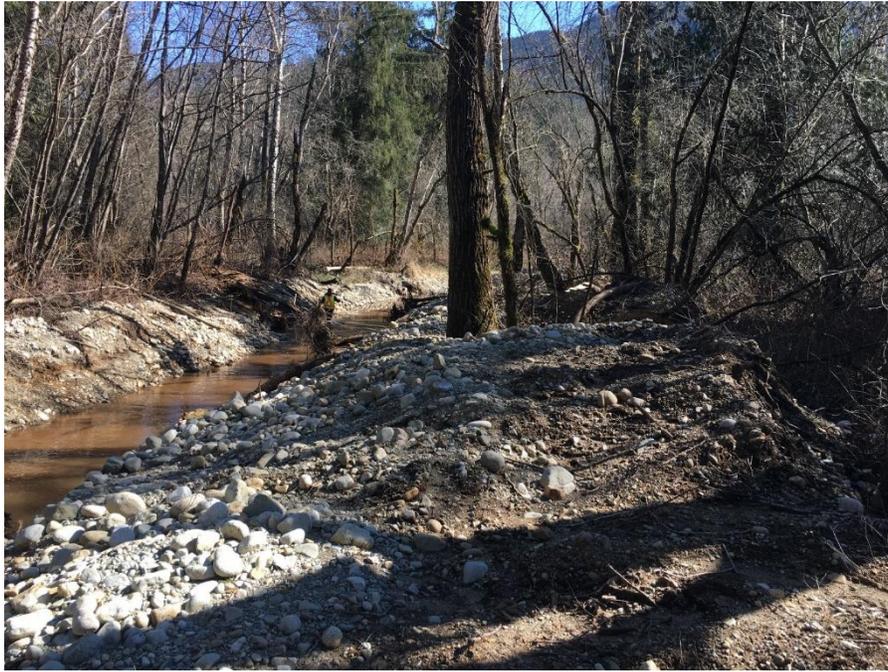
**Photo 4** March 16, 2020 – Example of riparian restoration area on Nancy Phillips Slough

The substrate present at Nancy Phillip slough contains topsoil on the southern banks of the slough however on the northern banks and above the top of bank the majority of the substrate is cobble which would restrict growth potential from plantings.

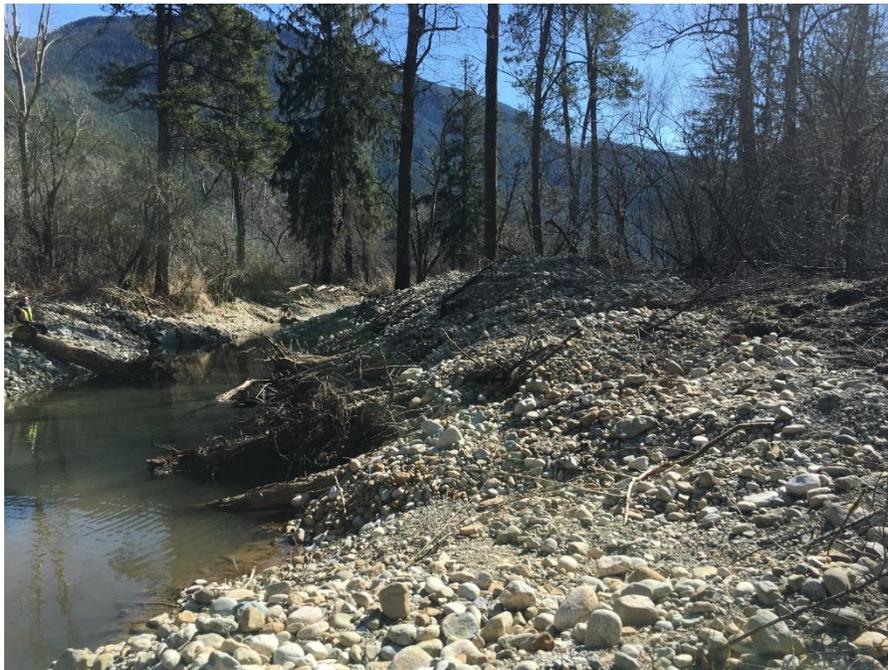
**Photo 5** March 16, 2020 – Example of riparian restoration area on Nancy Phillips Slough

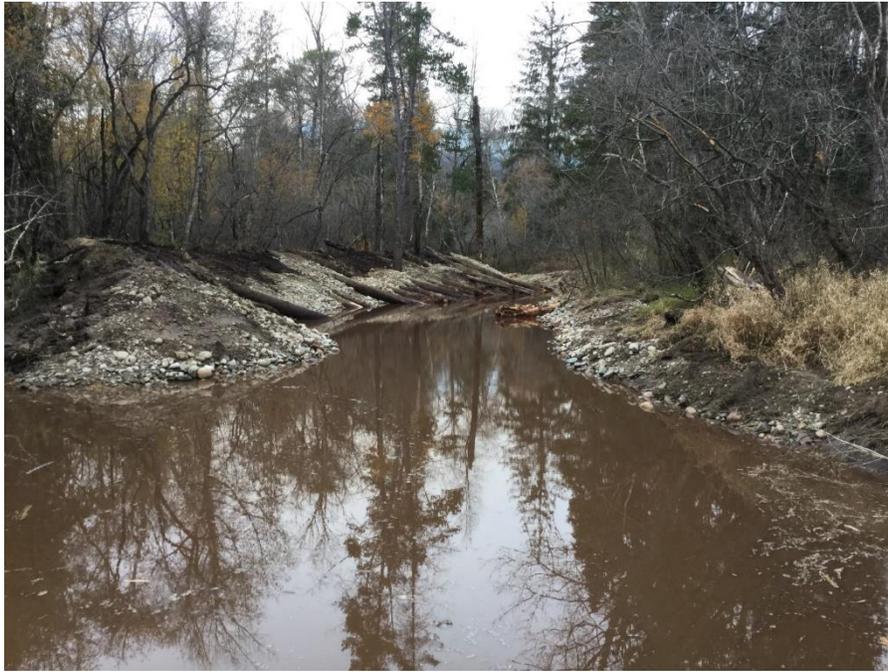
**Photo 6** November 7, 2019 - North view of planting area at Nancy Williams Slough.
