March 26, 2020
File No. 104486-01

Re: William Phillips slough Restoration – Post Construction Report

**William and Nancy Phillips Slough
As-built Drawing**

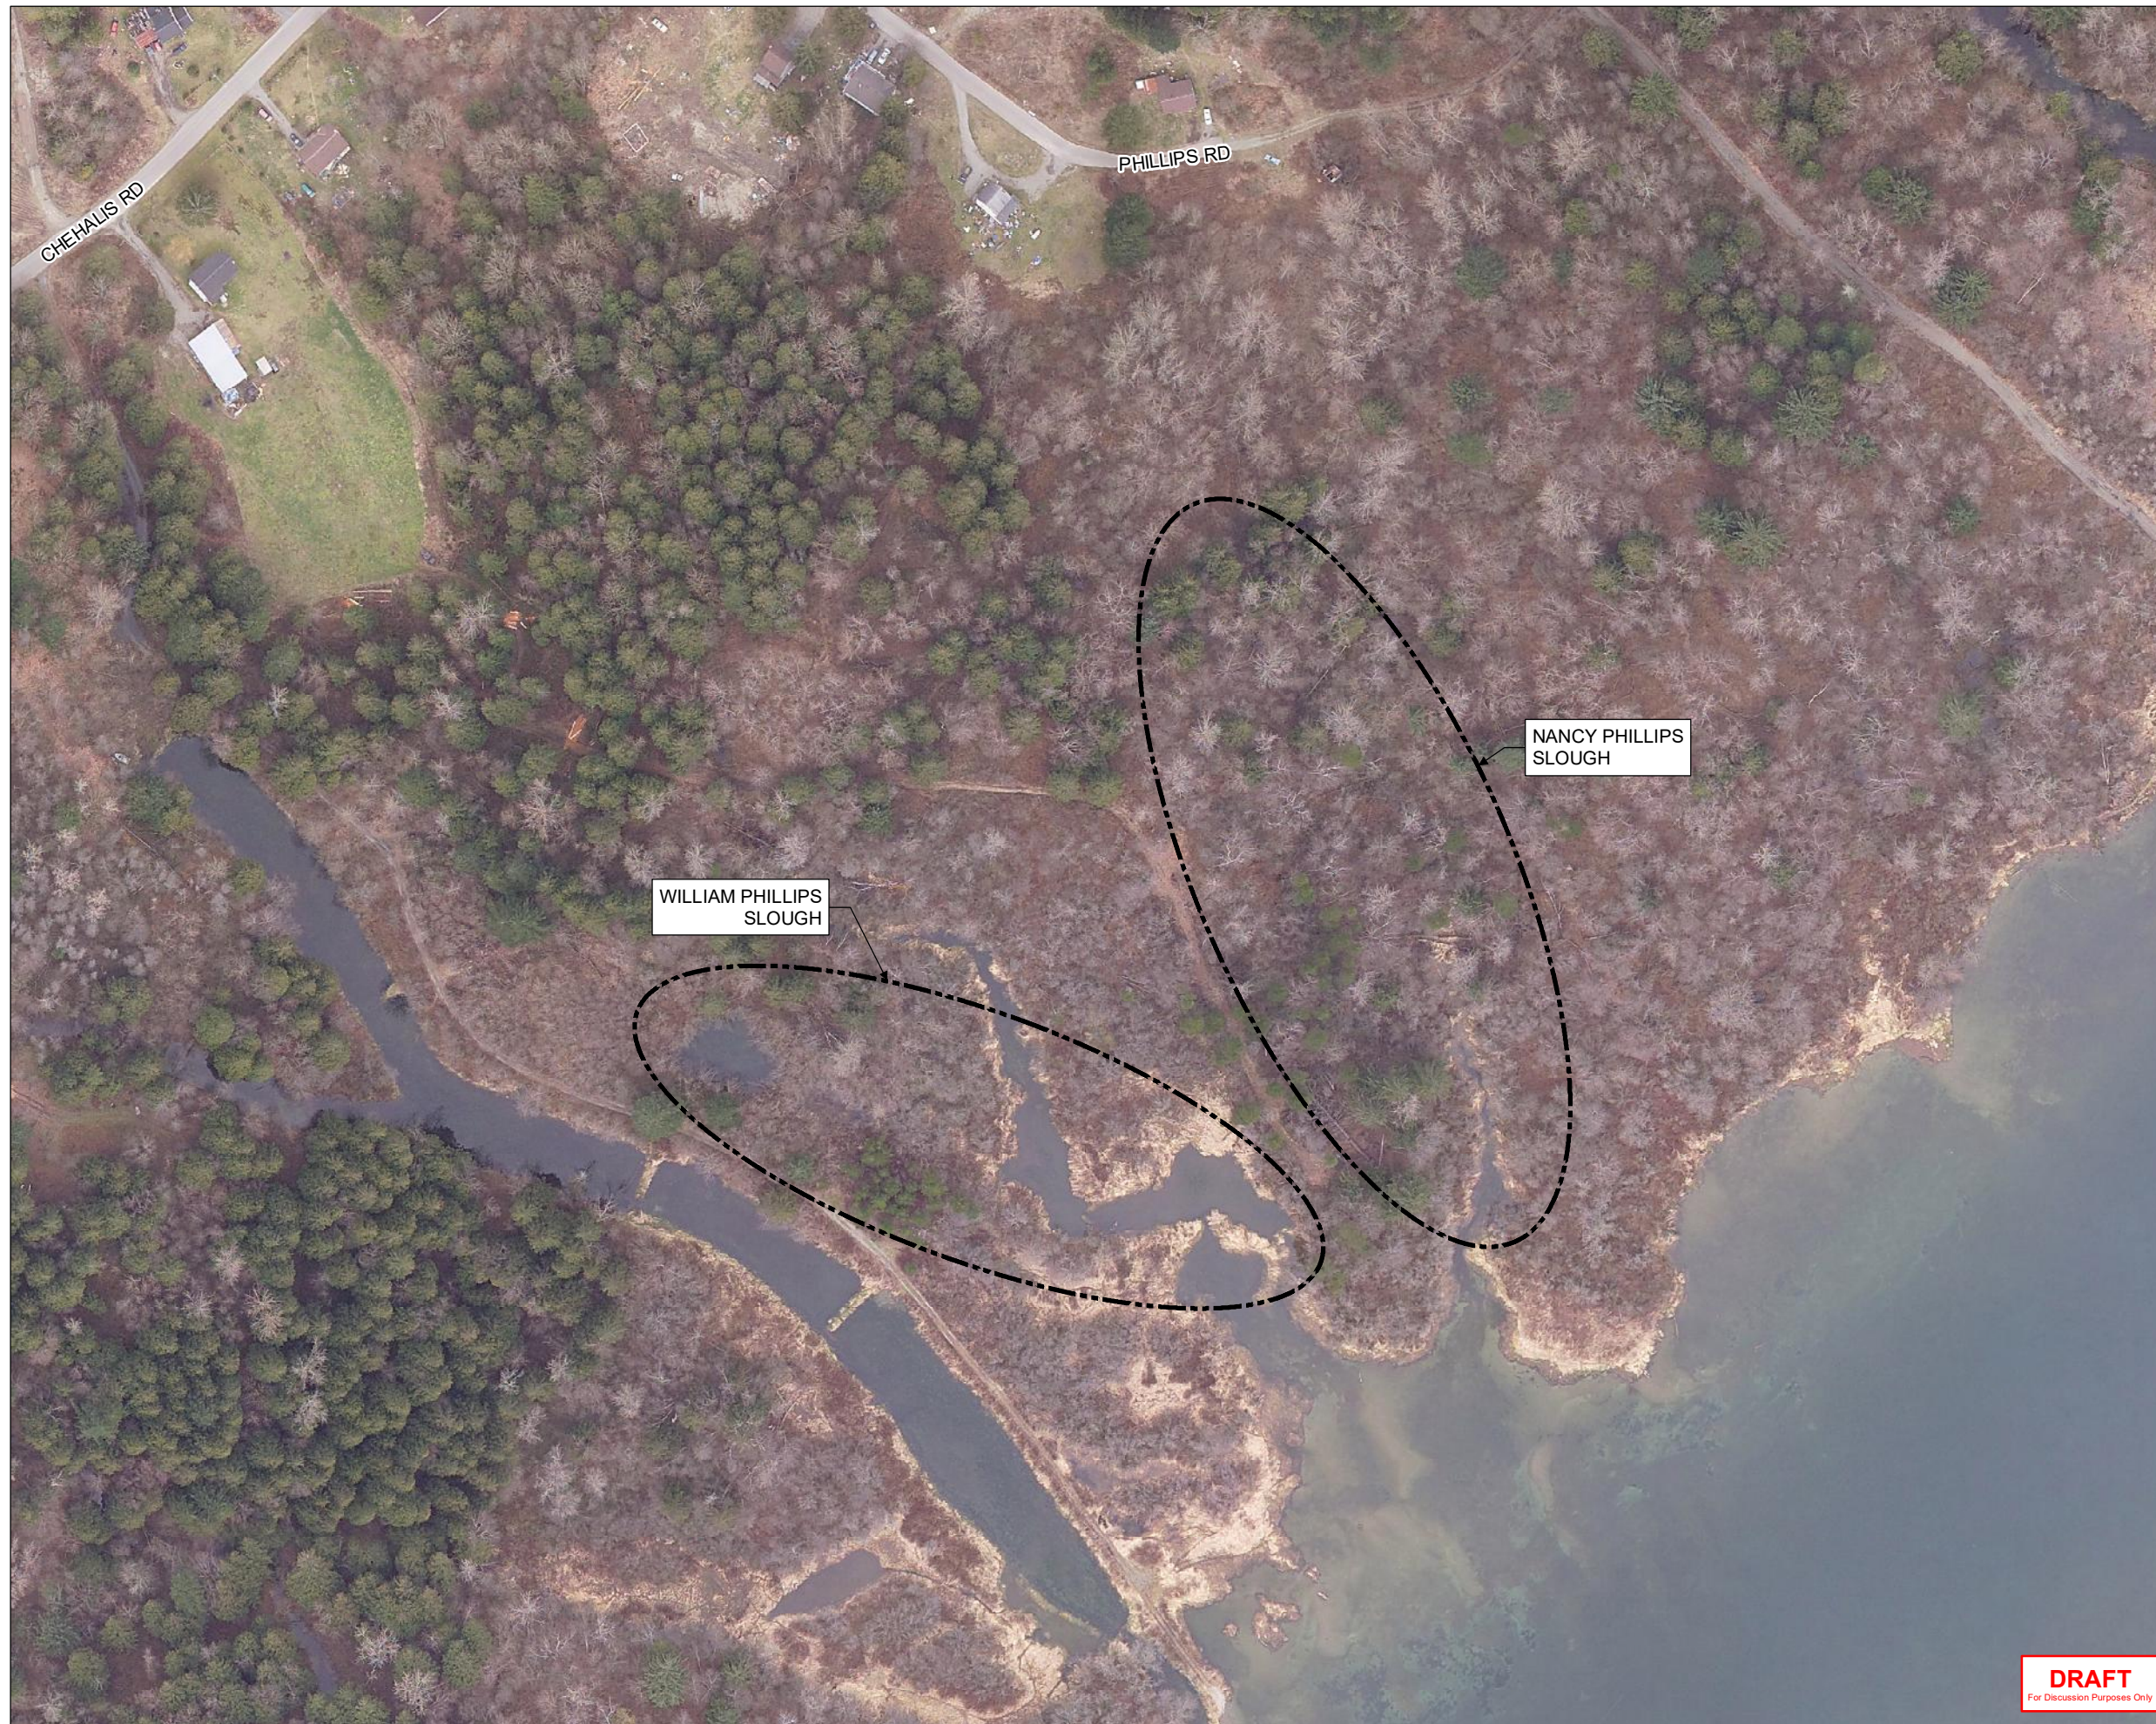
Figure 1

**Location and Pre-construction Condition of
Nancy and William Phillips Slough**

Prior to restoration, William Phillips Slough consisted of a wetland that functioned as over-wintering/rearing habitat for juvenile salmonids (**Figure 1**). The wetland substrate was composed of soft organics with milfoil, reed canary grass, and slough grasses observed throughout the wetted area. The wetland was located upstream of a large beaver dam located approximately 50 m upstream from the Harrison River confluence. Fish access into the wetland habitat depended on beaver activity. At the time of pre-construction assessments there was an outflow channel past the dam that remained open and appear accessible by juvenile fish. Juvenile salmonids were observed in the wetland habitat on several occasions. An existing pond habitat, remnant of past gravel removal activities, was located approximately 80 m upstream of the original slough alignment. The pond was isolated and not connected to fish habitat.

Nancy Phillips Slough is located immediately adjacent to William Phillips Slough (**Figure 1**). Nancy Phillips Slough consisted of a wetted channel (with no flow) that was approximately 50 m long and largely infilled with grasses. The channel upstream had naturally infilled over time and become terrestrial habitat.

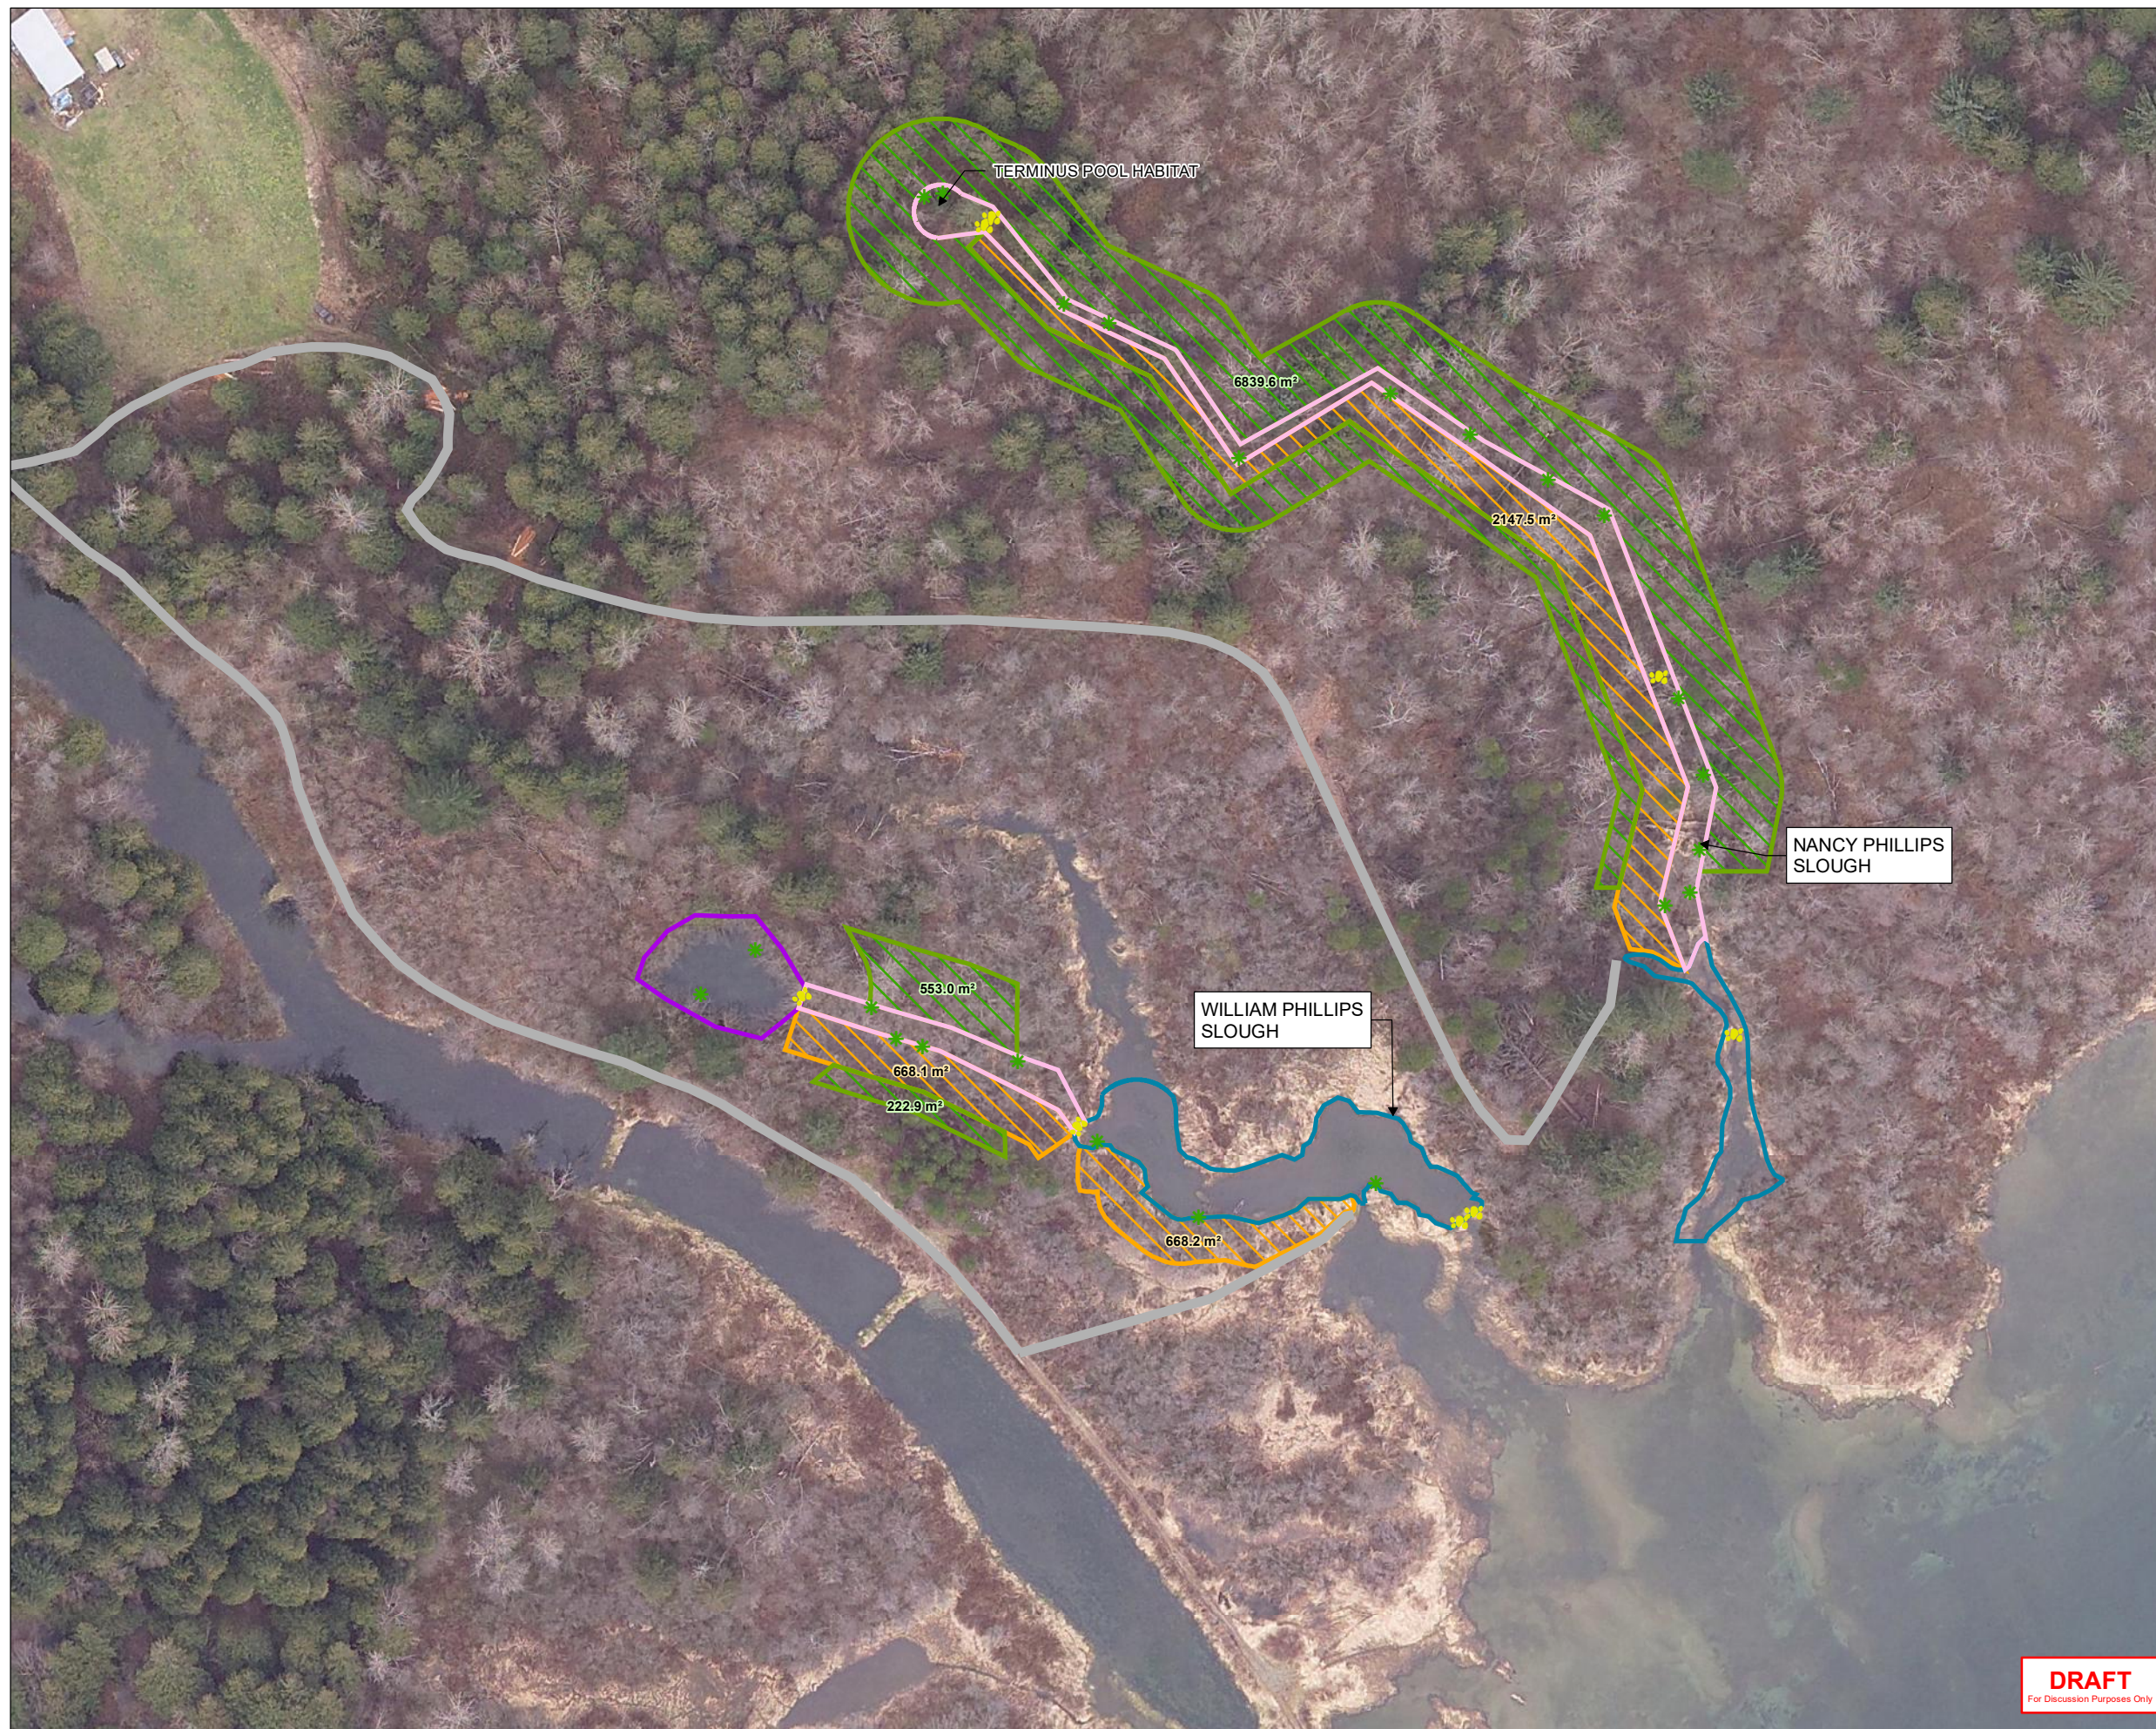
- Rock Weir
- Large Woody Debris
- Access Road
- Existing (Approximate Area: 1,946 m²)
- Enhance (Approximate Area: 726 m²)
- New (Approximate Total Area: 1,916 m²)
 - Nancy Phillips Slough Approximate Area: 1,486 m²
 - William Phillips Slough Approximate Area: 430 m²
- Riparian Planting (Approximate Area: 3,483 m²)
- New Riparian Area (Approximate Area: 7,615 m²)

Construction of the project commenced on October 11, 2019 and was completed on November 8, 2019. A description of each project component is described in the following sections. As-built drawings (**Figure 2**) are attached. As previously noted, the project was field-fit, so exact excavation volumes are not available.

- 1) Excavation of a new channel to connect a pre-existing pond habitat to the wetland habitat (thereby providing fish access into the pond)
- 2) Removal of fine/organic sediment and vegetation that had infilled the wetland habitat. During excavation of the wetland, a low flow channel was created parallel to the right (south) bank to ensure connectivity at low water conditions. Additionally, LWD structures were installed throughout the new and existing habitats in embayments along the right bank to provide habitat complexity. Three rock weirs were constructed at strategic locations to increase the water level upstream of each weir and to concentrate flow. The downstream weir was installed across the existing beaver dam (**Figure 2**). A break down of construction activities is provided in **Table 1**.

Construction of Nancy Philips Slough consisted of excavating a new channel along the alignment of the historic slough channel which had infilled over time and had become terrestrial habitat. Two pool habitats were excavated within the channel: one at the upstream terminal end, and a second midway down the channel. Approximately 20 LWD structures were installed approximately every 20 m in embayments in the channel banks. Finally, three weirs were constructed at strategic locations to concentrate flow and to increase the water level upstream (reducing excavation volumes) (**Figure 2**). A break down of construction activities is provided in **Table 2**.

Riparian planting was planned to be executed during site construction but was not undertaken due to timing constraints. Candidate locations for riparian planting have been identified on the as-built figures for each slough and are outlined in **Table 4**. These proposed planting areas generally overlap with habitat disturbed by machine operation.

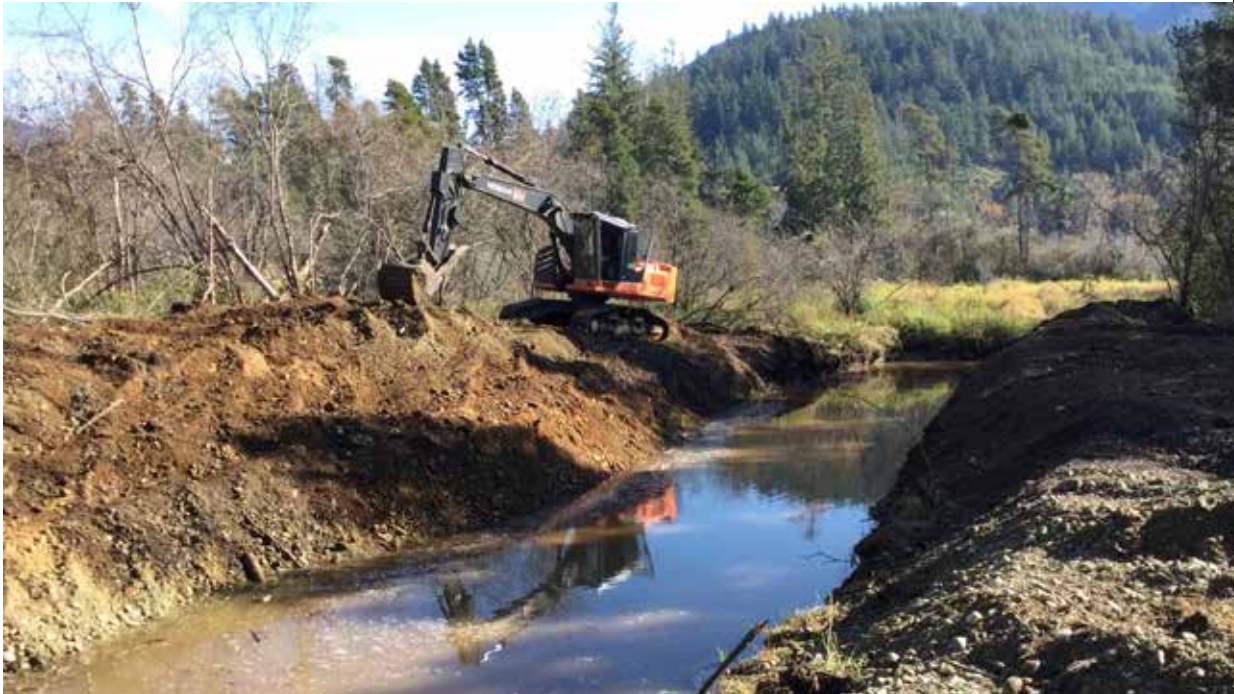
Photo 1 October 11, 2019 – Beginning of excavation of channel at Williams Phillips Slough.

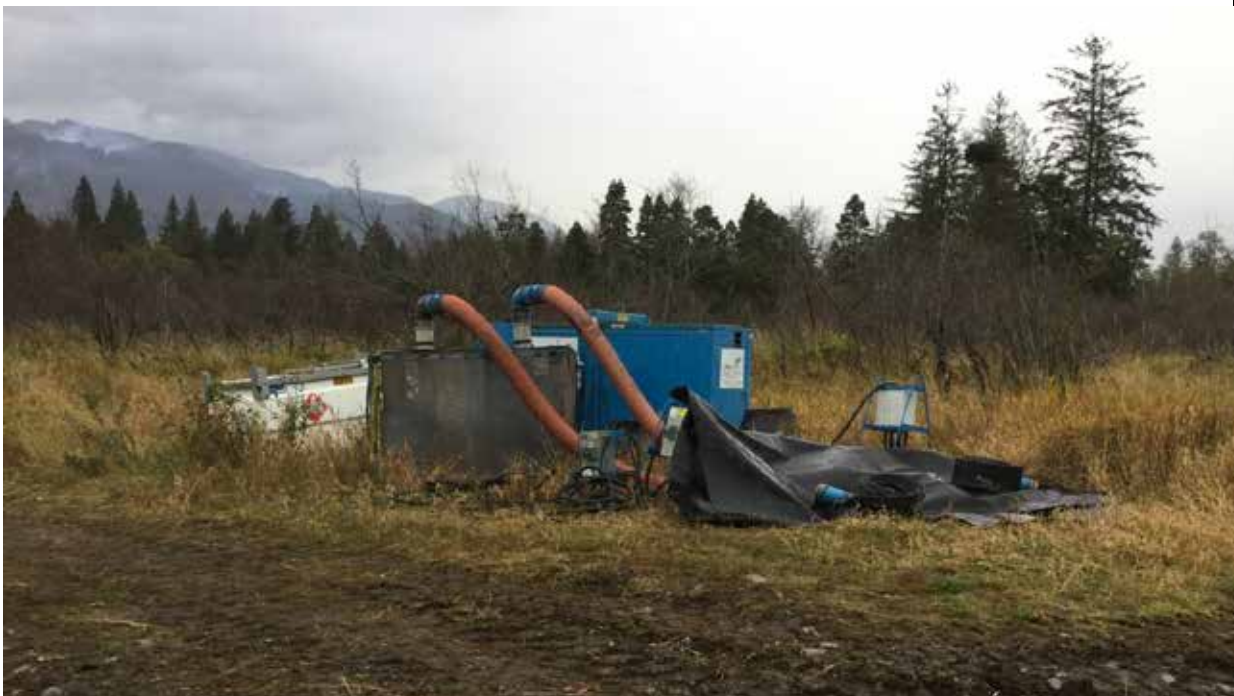
Photo 2 October 15, 2019 – Pumps used for dewatering of the work area at William Phillips Slough.

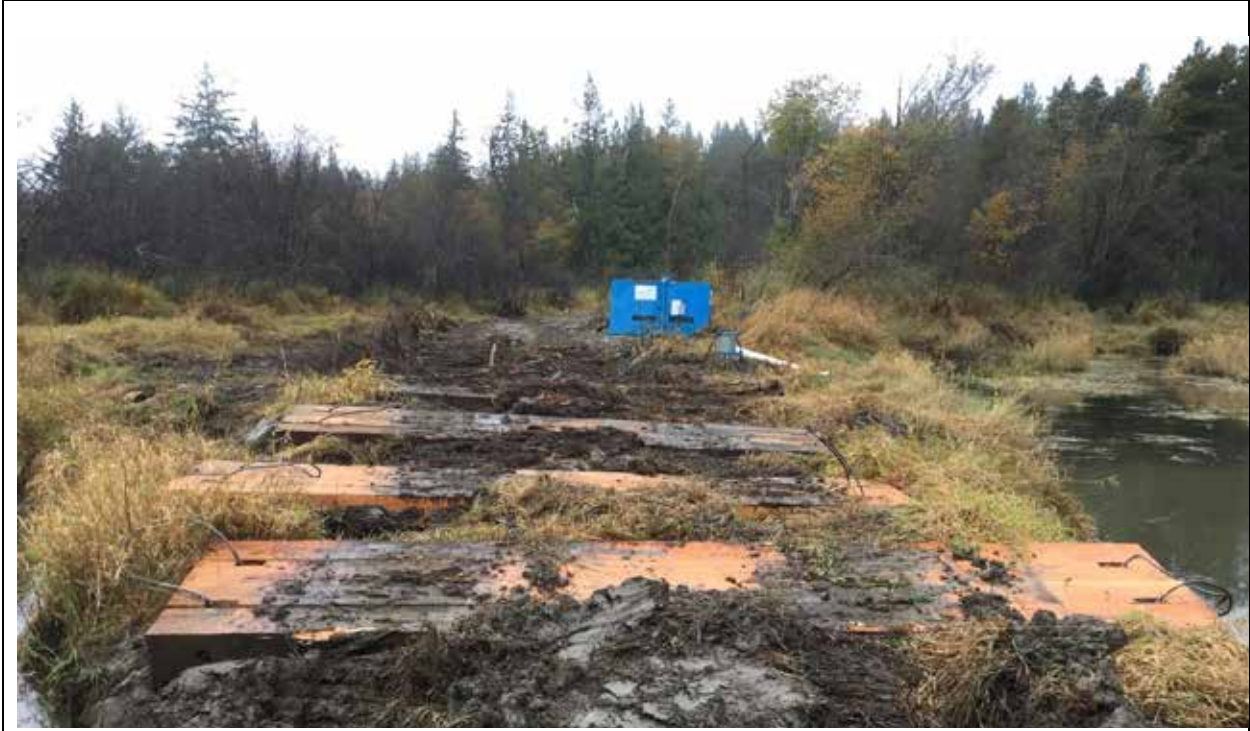
Photo 3 October 17, 2019 – Swamp mats laid out for machine access on William Phillips Slough.

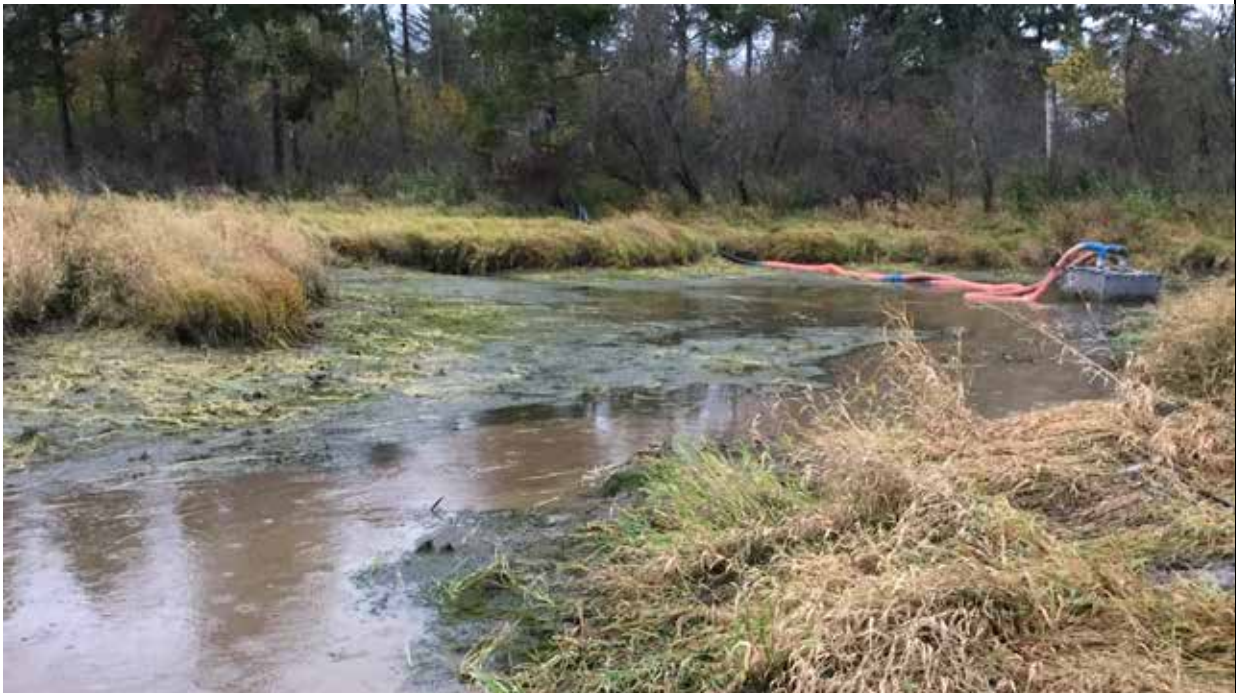
Photo 4 October 18, 2019 – Dewatering of work area at William Phillips Slough.

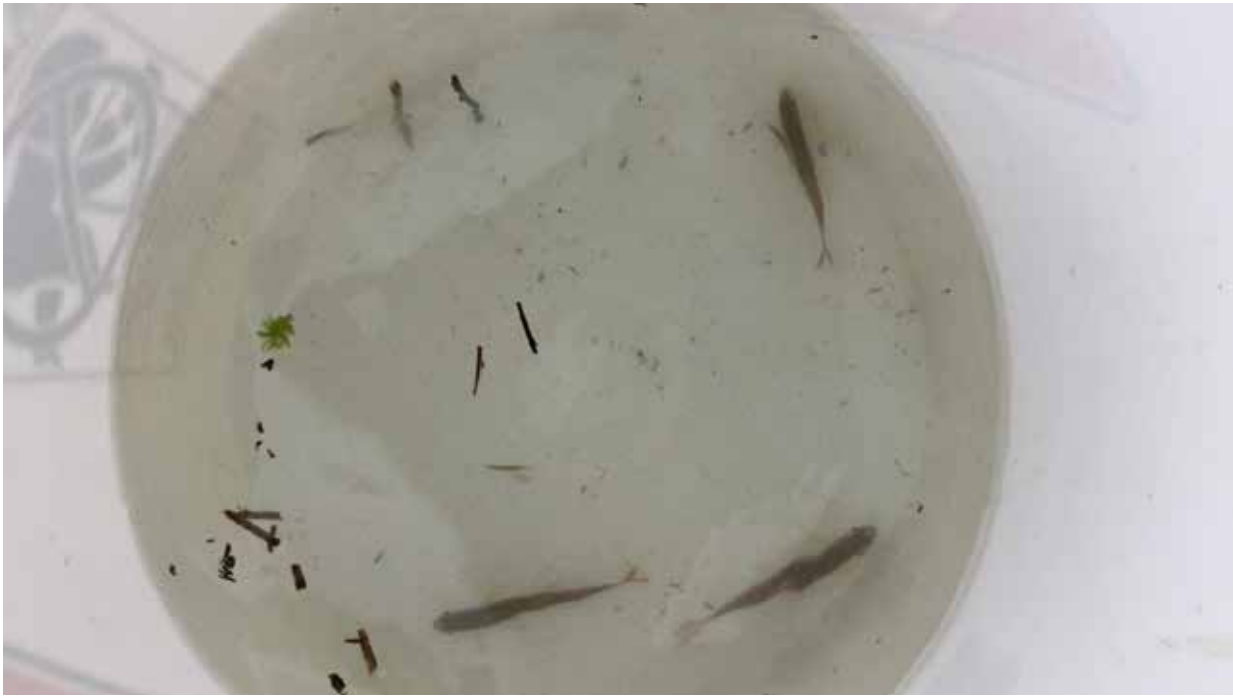
Photo 5 October 18, 2019 – Coho fry captured during fish salvage at William Phillips Slough.

A fish salvage was conducted in William Philips Slough wetland habitat prior to the start of construction. Approximately 40 minnow traps were deployed within the main channel and checked over a period of several days. Additionally, during dewatering, the EM used a dip-net to salvage any remaining fish observed. The salvaged fish primarily consisted of juvenile coho salmon (*Oncorhynchus kisutch*), threespine stickleback (*Gasterosteus aculeatus*), and northern pikeminnow (*Ptychocheilus oregonensis*). Additionally, three northwestern salamanders were captured. Fish and amphibians were released downstream of the isolation net at the confluence of William Philips Slough and the Harrison River. Fish salvage results are summarised in **Table 3**.

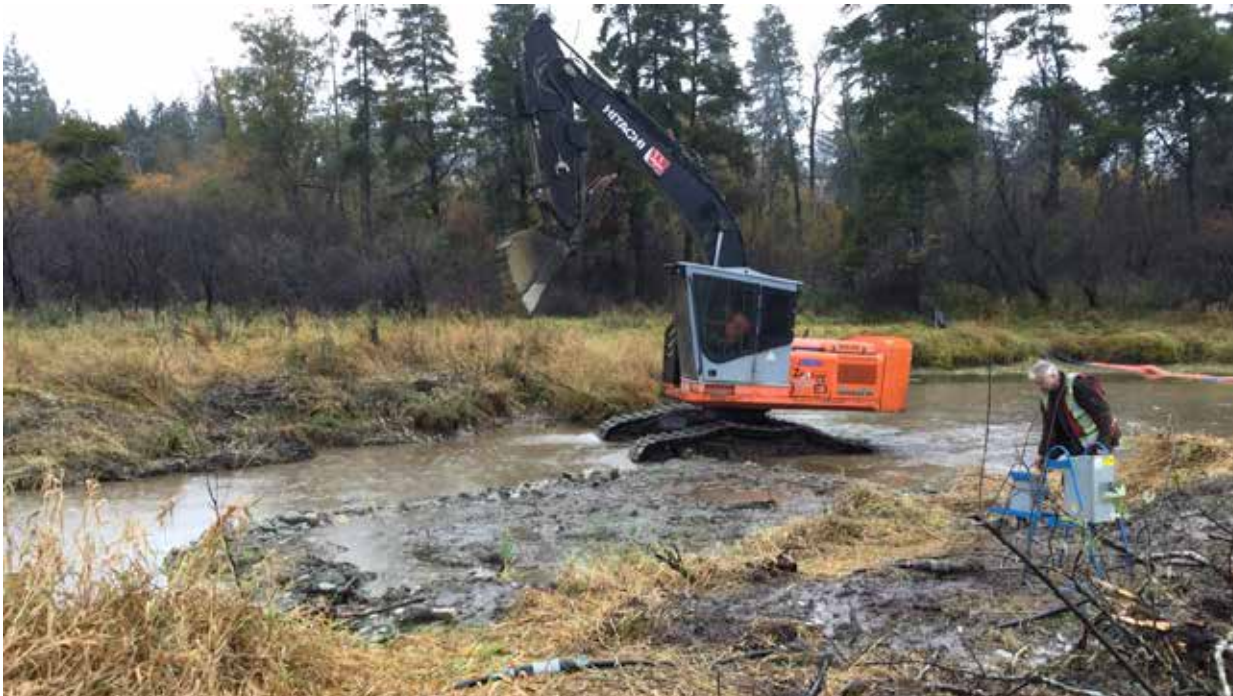
Photo 6 October 21, 2019 – Channel excavation at William Phillips Slough.

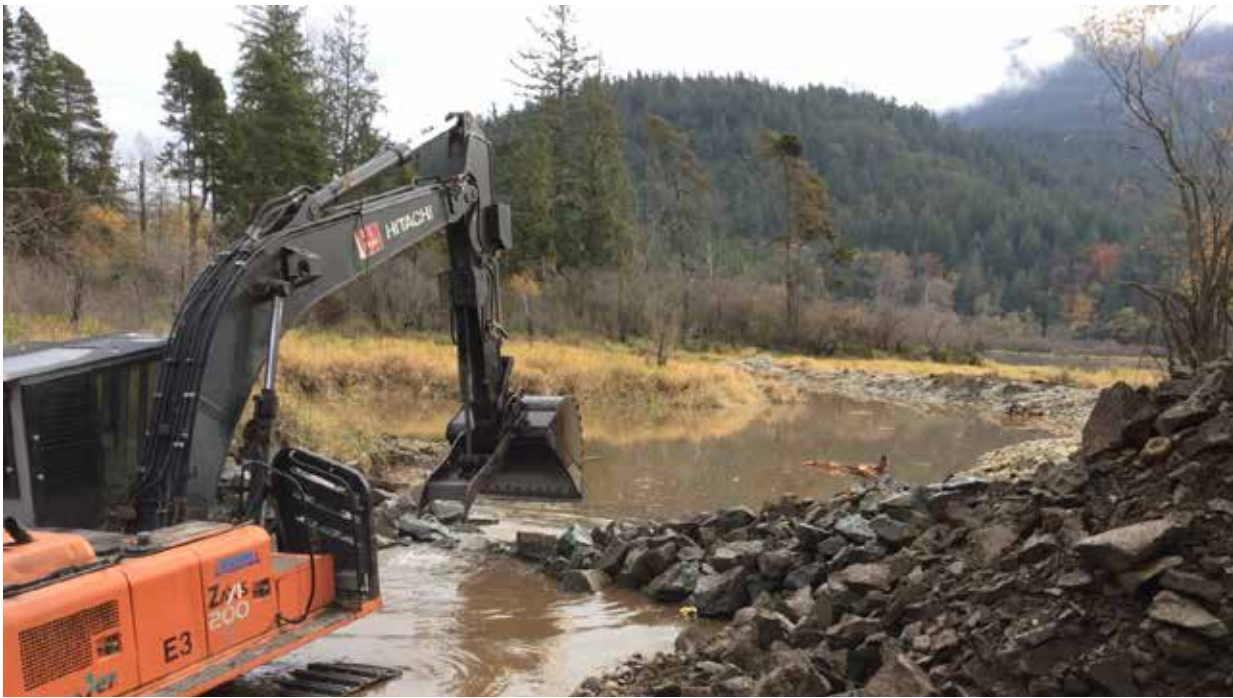
Photo 7 October 24, 2019 - Marhag equipment installing a rock weir on William Phillips Slough.

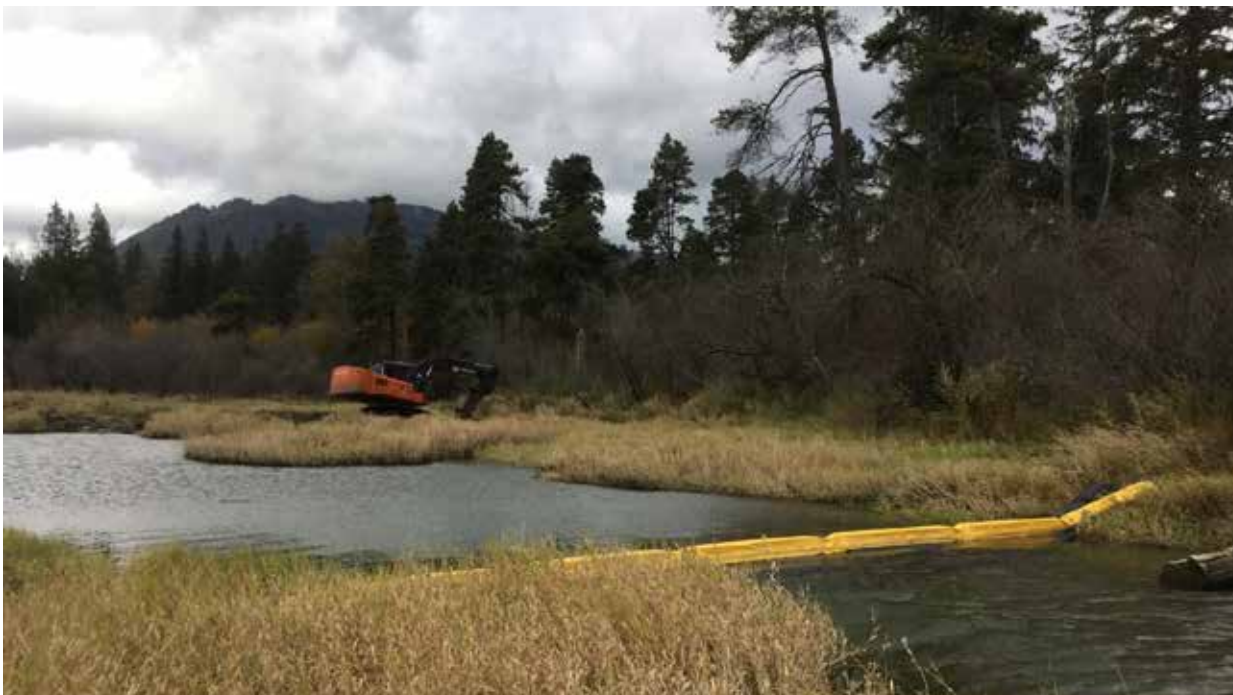
Photo 8 October 25, 2019 – Silt curtain at downstream extent of the William Phillips Slough to isolate work area.

Soil material was temporarily placed in the outflow gap in the existing beaver dam on William Phillips Slough to prevent discharge of sediment-laden water from the site during construction. Additionally, a silt curtain was installed downstream of the beaver dam to prevent potential sediment release into the Harrison River. A 6-inch water pump was employed during excavation to further reduce the water level within the wetland and remove turbid water. Water was discharged into an adjacent vegetated area.

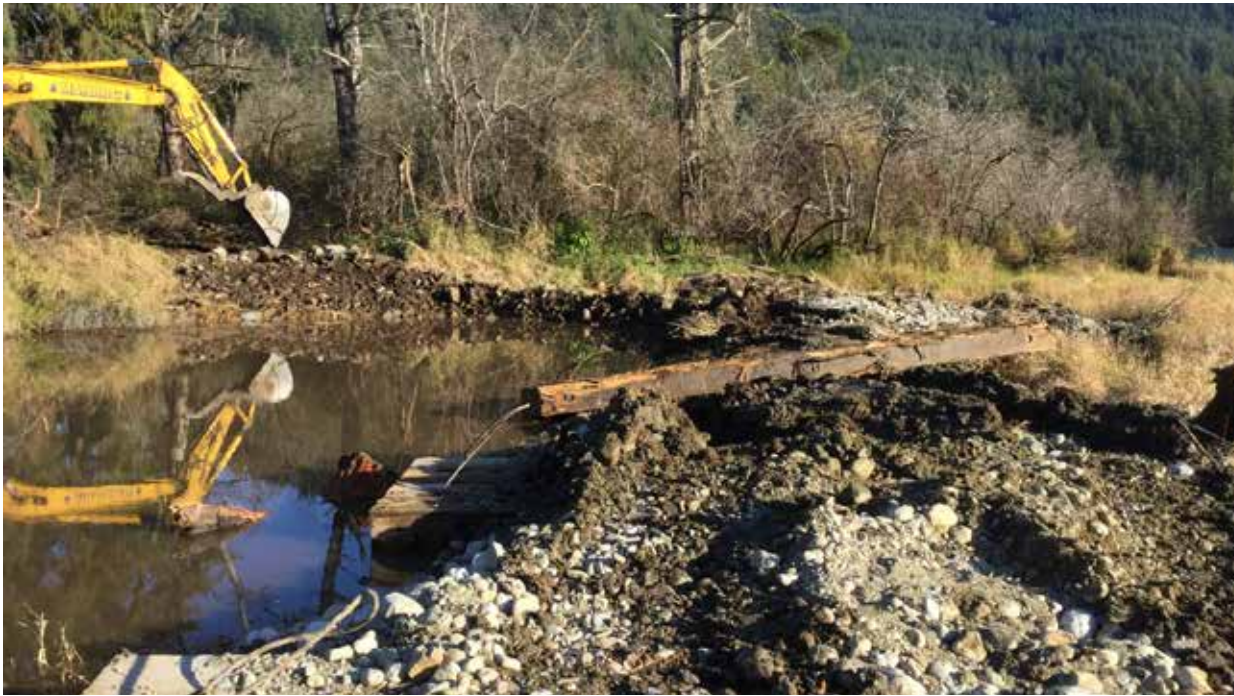
Photo 9 October 28, 2019 – LWD installed at William Phillips Slough

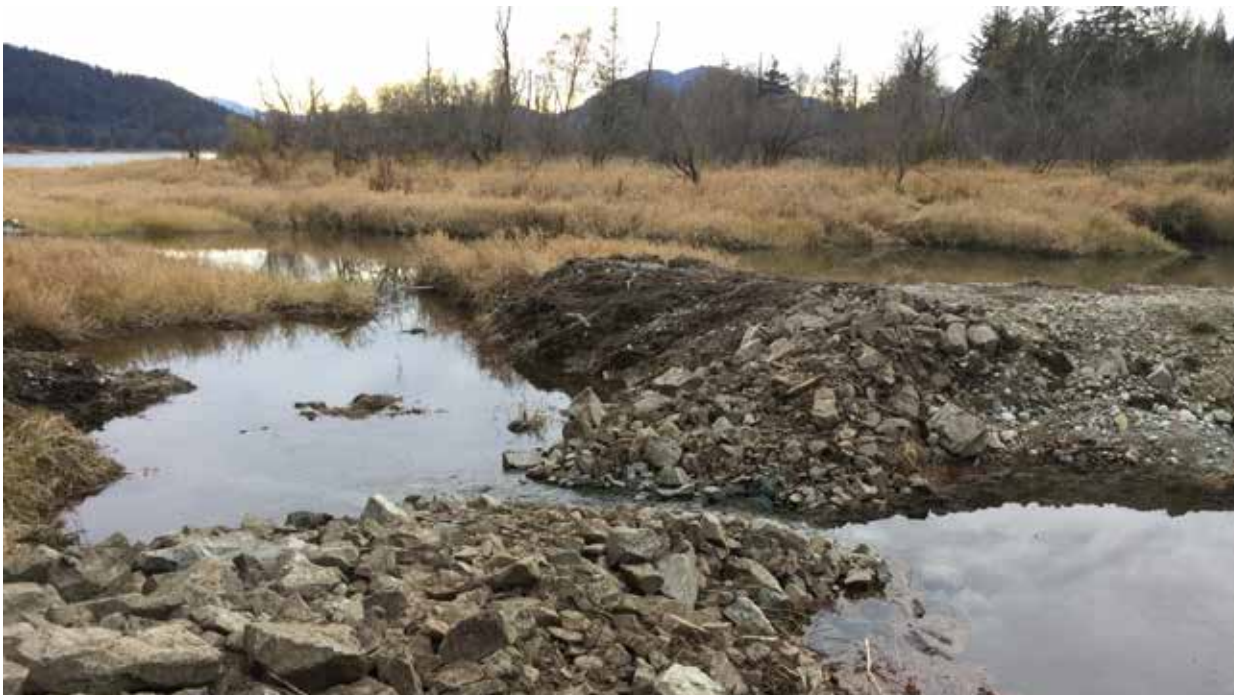
Photo 10 November 7, 2019 – West view of the downstream rock weir at William Phillips Slough.

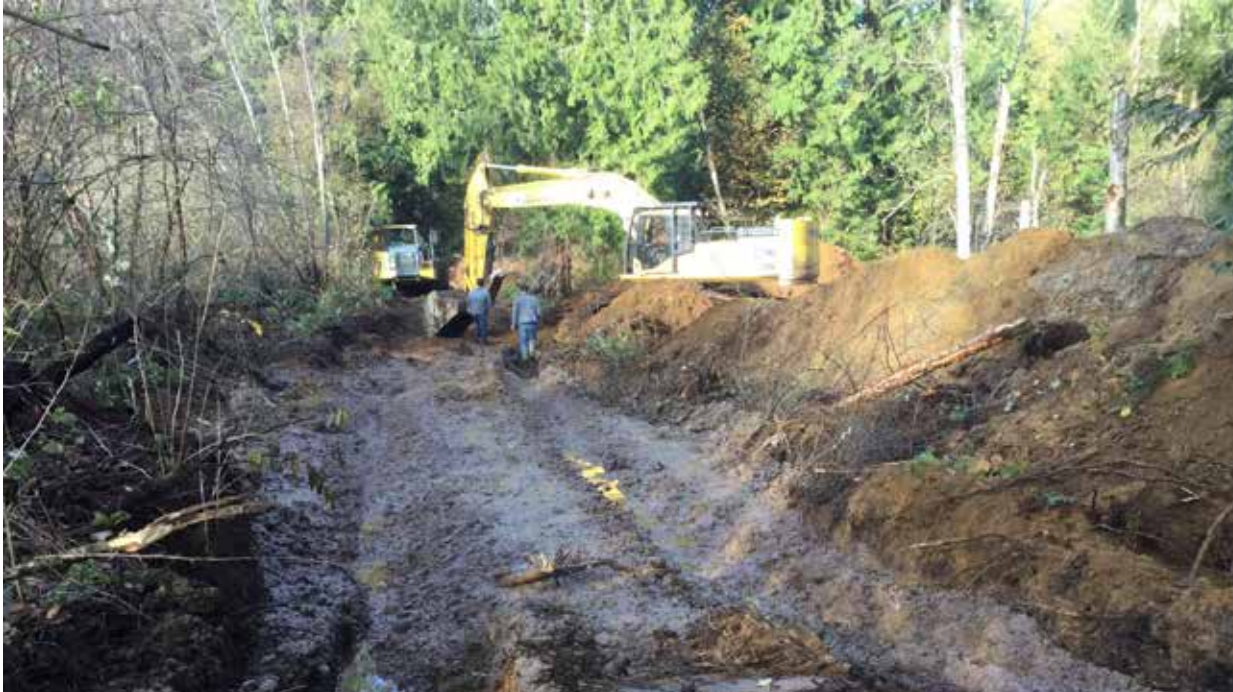
Photo 11 October 28, 2019 - Marhag construction beginning slough excavation at Nancy Phillips Slough.

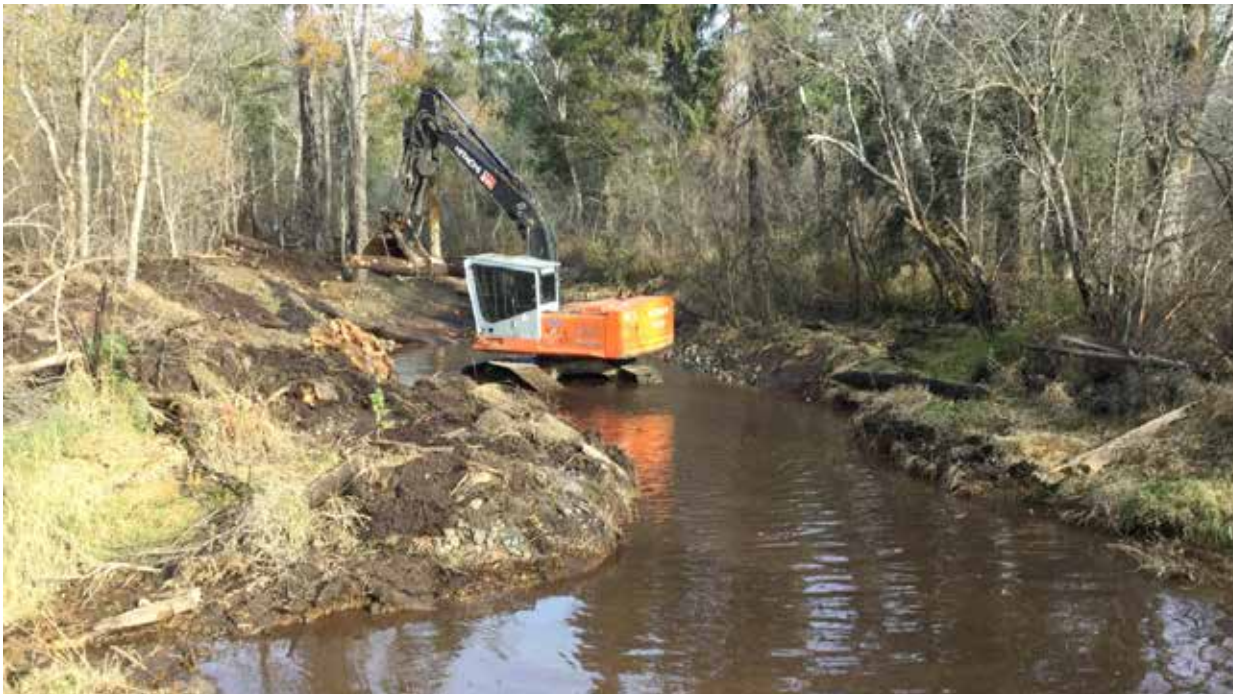
Photo 12 November 7, 2019 - Marhag construction placing LWD in Nancy Phillips Slough.

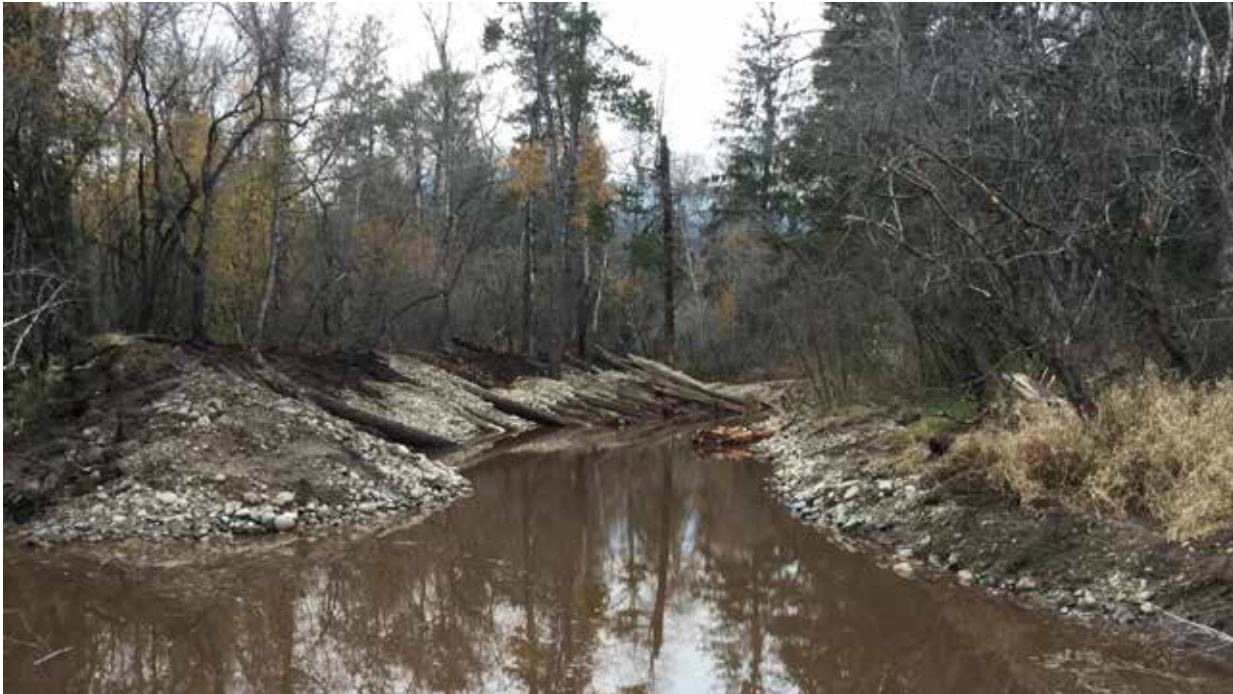
Photo 13 November 7, 2019 - North view of construction channel near the north end of Nancy Phillips Slough.

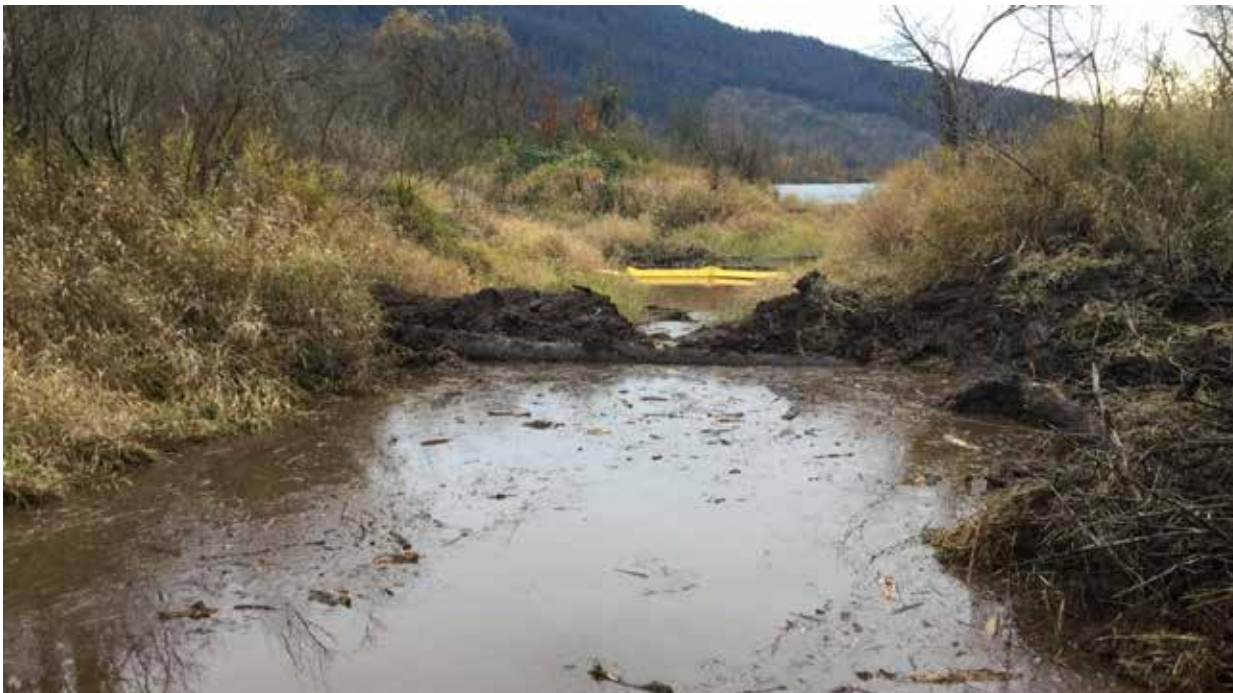
Photo 14 November 7, 2019 - View of earth berm and silt current used to isolate the construction area at Nancy Williams Slough.

Nancy Philips Slough was terrestrial habitat at the time of construction. Prior to excavation, an earth berm was built across the channel immediately upstream of the existing wetted channel to retain water released during new channel excavation. A silt curtain was also installed downstream of the work area within the existing channel to prevent sediment release to the Harrison River.

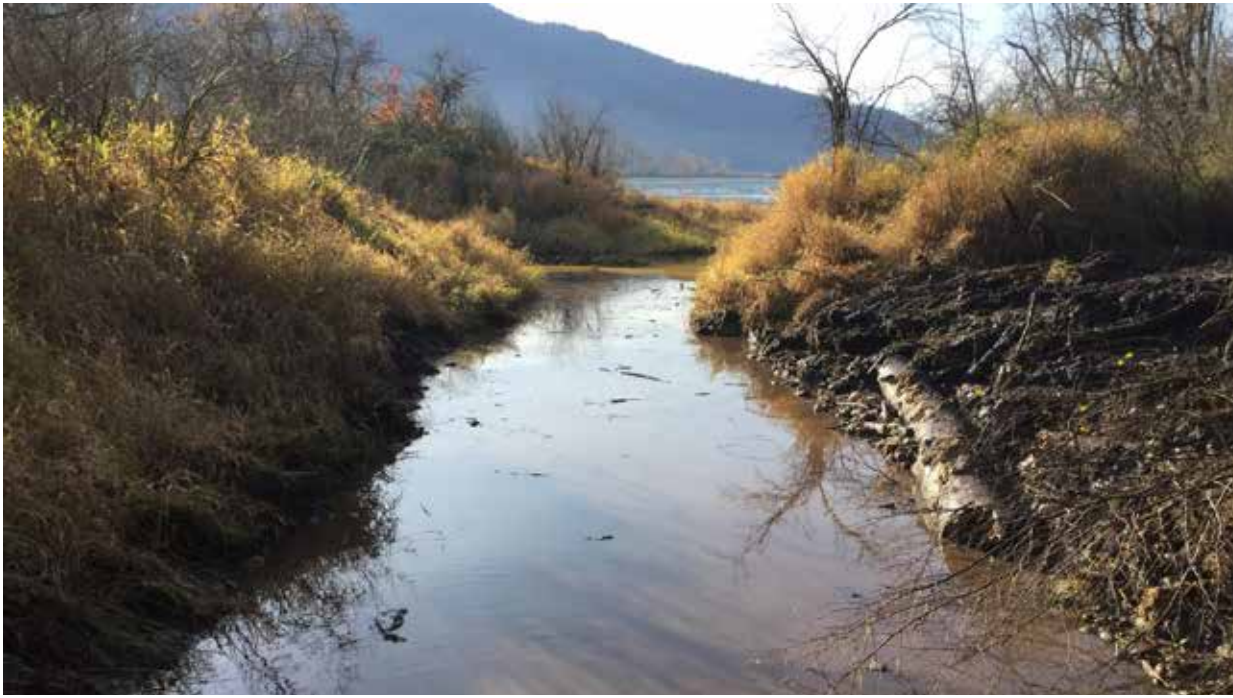
Photo 15 November 8, 2019 – View of silt current at confluence of the Nancy Phillips Slough that leads to the Harrison River.

Post-construction monitoring of habitat function was not conducted immediately after construction due to the timing of project completion and the salmon spawning window. The silt curtain was not removed from the outlet of Nancy Philips Slough to avoid disturbing the adult salmon were observed spawning immediately downstream of it and also the eggs in the gravel. The silt curtain will be removed in spring 2020 when disturbance to salmon embryos and alevins is expected to be minimal.
