Baseline Survey Report 2020

Fish, Amphibian and Habitat Surveys Restoration Opportunities at Sq'ewlets

Prepared For:
Sq'ewlets First Nation
And
Fraser Valley Watersheds Coalition

By
Pearson Ecological
Agassiz BC

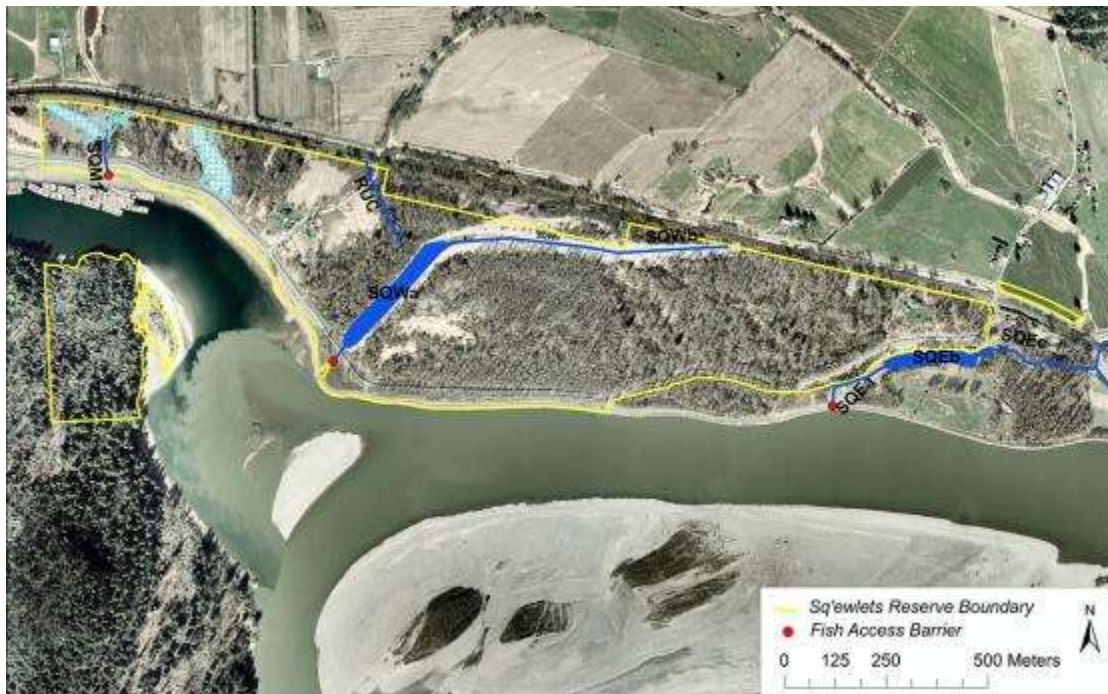
Figure 1: Waterbodies of Sq'ewlets Reserve 1. Codes refer to reaches identified in the habitat survey.

Sq'ewlets Reserve 1 contains Squawkum Creek, Sq'ewlets Slough West and Sq'ewlets Marsh (Figure 1). It also borders Sq'ewlets Slough East. Squawkum Creek 3 Reserve contains Squawkum Creek (outlet stream to Lake Errock), Sasin Creek (BC Gazette Name), Campground Creek (our arbitrary name), the outlet of Sq'ewlets Creek North (our arbitrary name) and 13 spring fed channels that arise in, or just above, the floodplain on the west shore of Harrison Bay (Figure 2).

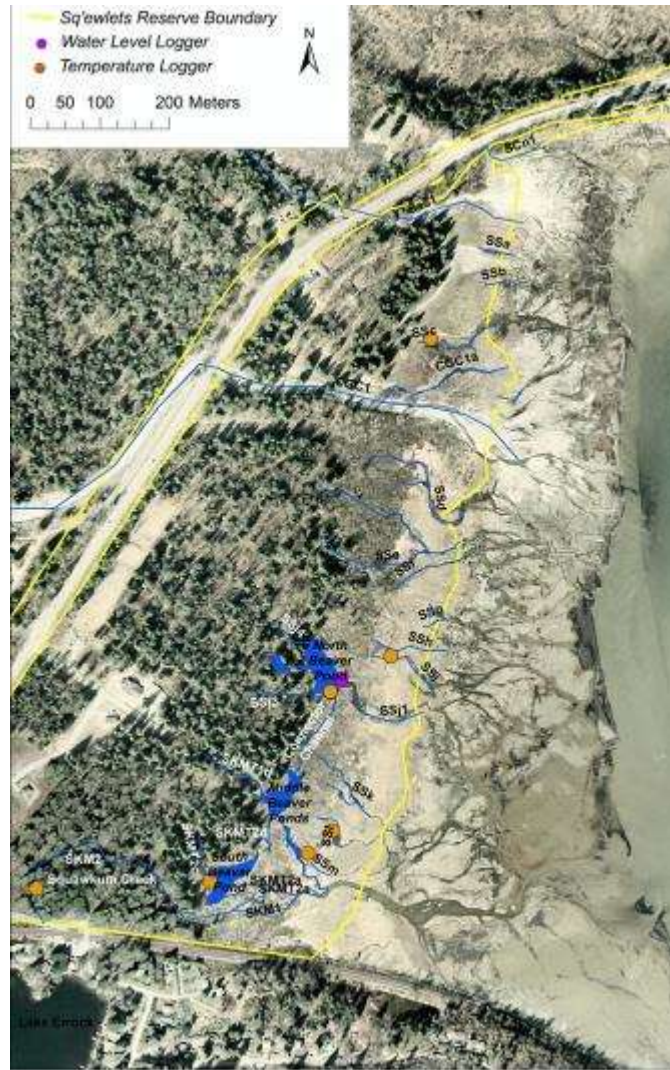
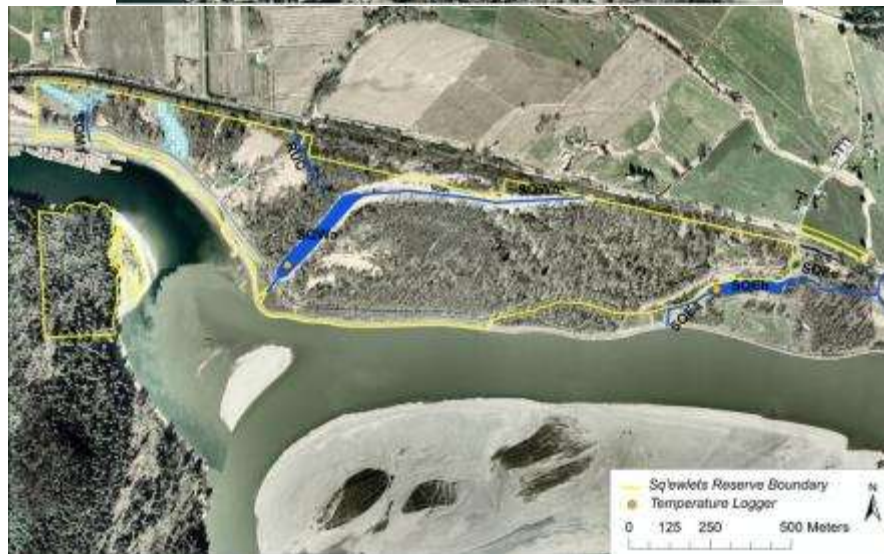
Figure 3: Locations of loggers at Squawkum Creek 3 and Sq'ewlets 1 Reserves.

Temperature loggers (Onset HOBO MX2201) and a water depth logger (Onset HOBO Model: E-348-U20L) were installed at key locations in the study area to take hourly readings (Table 2, Figure 3).

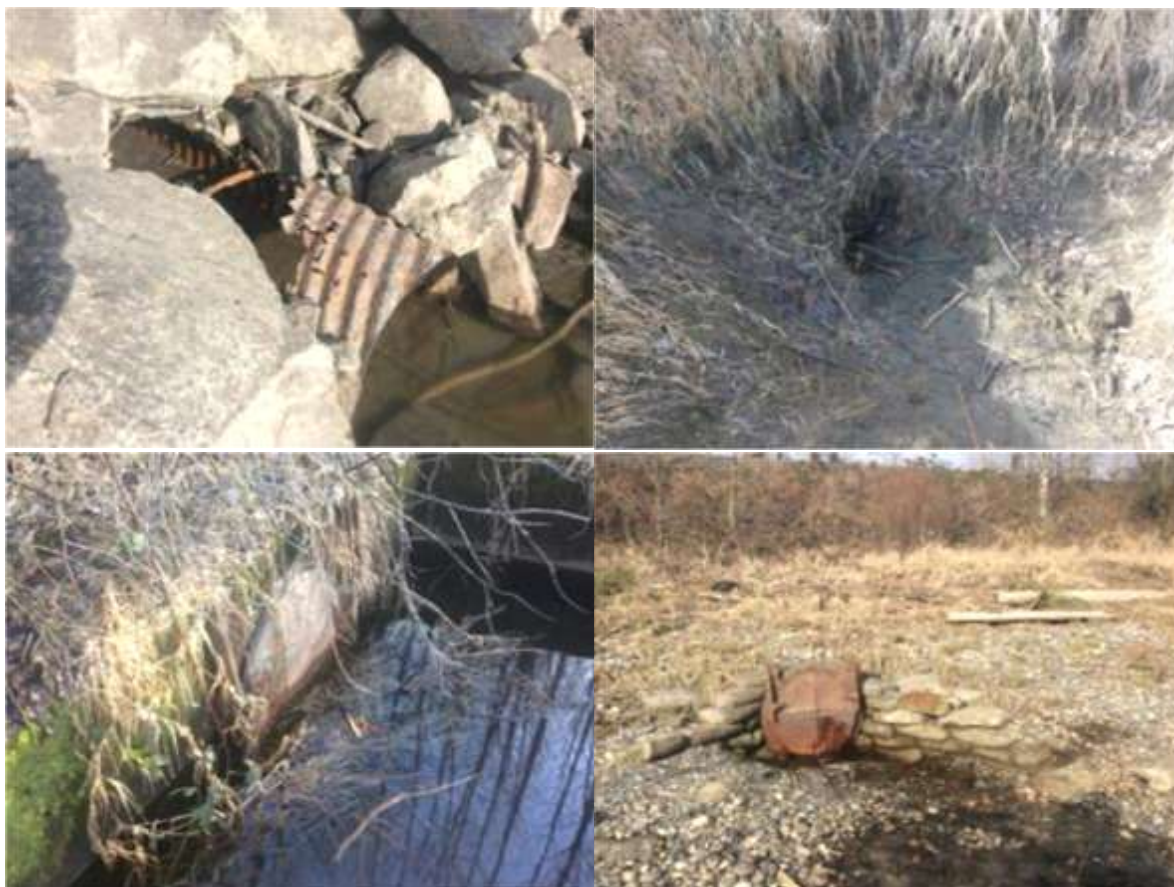
Sq'ewlets Slough East is not currently accessible to fish from the Fraser River. Passage is blocked by a secondary dyke at the river's edge. A culvert was originally installed through it, but this has collapsed and is now completely buried in sediment on the inside of the secondary dike (Figure 4). The secondary dike would be overtopped in at least some freshets, which would provide some temporary fish access.

Sq'ewlets Slough West is not accessible to fish from the Fraser River. It is connected through the primary dike by a culvert fitted with a top-hinged flood gate (Figure 4). When the Fraser River is higher than the Slough level (most of the summer) water pressure keeps it shut tightly. When water levels are lower in the Fraser, there is not enough flow coming out of the Slough to open it significantly, because the flap is heavy and the hinges are on top, so it is effectively a permanent and complete barrier.

Figure 4: Access barriers to Sq'ewlets Slough East (Top), Sq'ewlets Slough West (bottom left) and Sq'ewlets Marsh (bottom right) on February 10, 2020.

5. **Sq'ewlets Slough East** is the most straightforward of the restoration projects as it could simply involve breaching the secondary dike at the Fraser River (which is regularly overtopped during freshets), providing full and permanent fish access to the slough. Additional work in the slough could consist of installation of large woody debris complexing, and deepening the two reaches that currently dry at low water levels. The site is easily accessible for machinery and is not on private land, although it is off-reserve. KWL will be conducting a high level engineering assessment and recommended approach for this project. The report is expected in early 2021, subject to pandemic related delays.

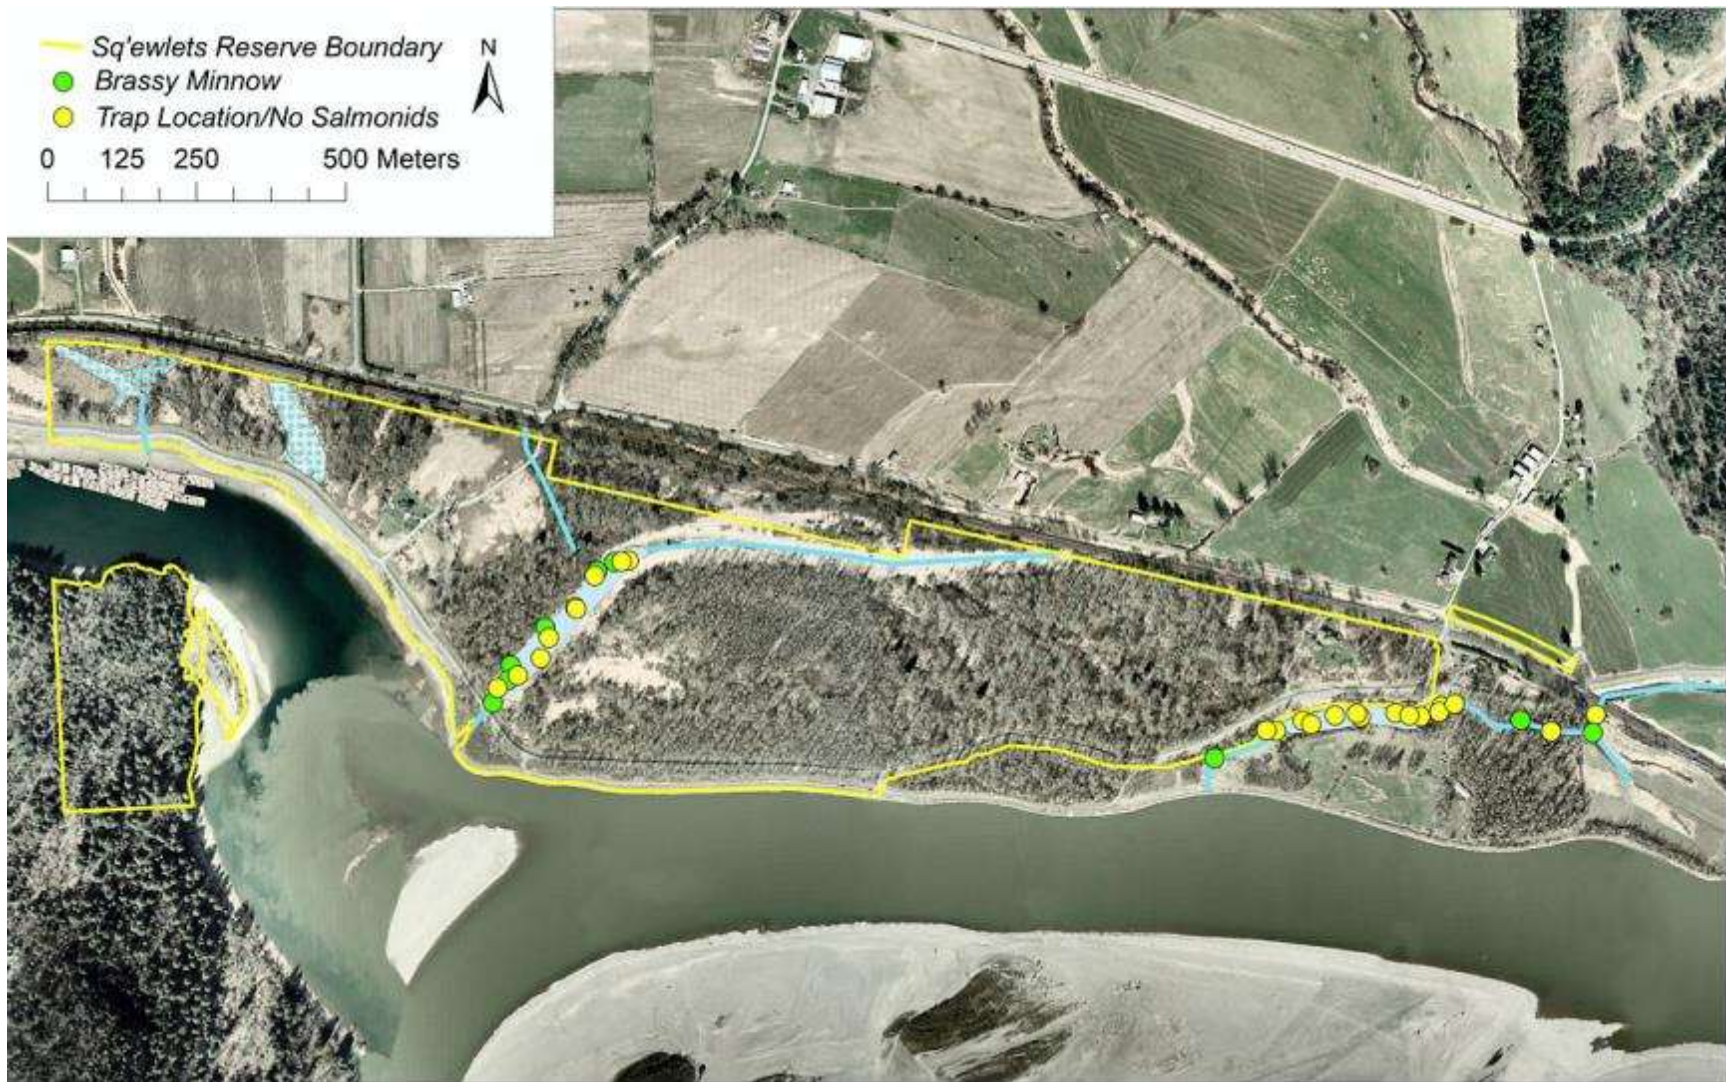
Figure 7: Locations of traps set and Brassy Minnow captured at Sq'ewlets 1.

A single juvenile Chinook Salmon was caught and a single Chum Salmon were caught in small spring fed channels in the floodplain in Gee traps. We suspect there were many more of both species present. Neither species typically enters minnow traps, nor were we able to seine these habitats during the study as virtually all areas are used by spawning Chum Salmon, and alevins would have been present in the gravel. Sixty chum salmon were caught in one of the Fyke net sets in Harrison Bay with a lead perpendicular to shore; presumably a school intercepted while moving along the shoreline. Five Coastal Cutthroat Trout were caught, all in beaver ponds of the Squawkum Creek tributaries. Over 400 Brassy Minnow, a species on the BC Blue List, were caught in the sloughs of Sq'ewlets 1 (Figure 7). BC Blue

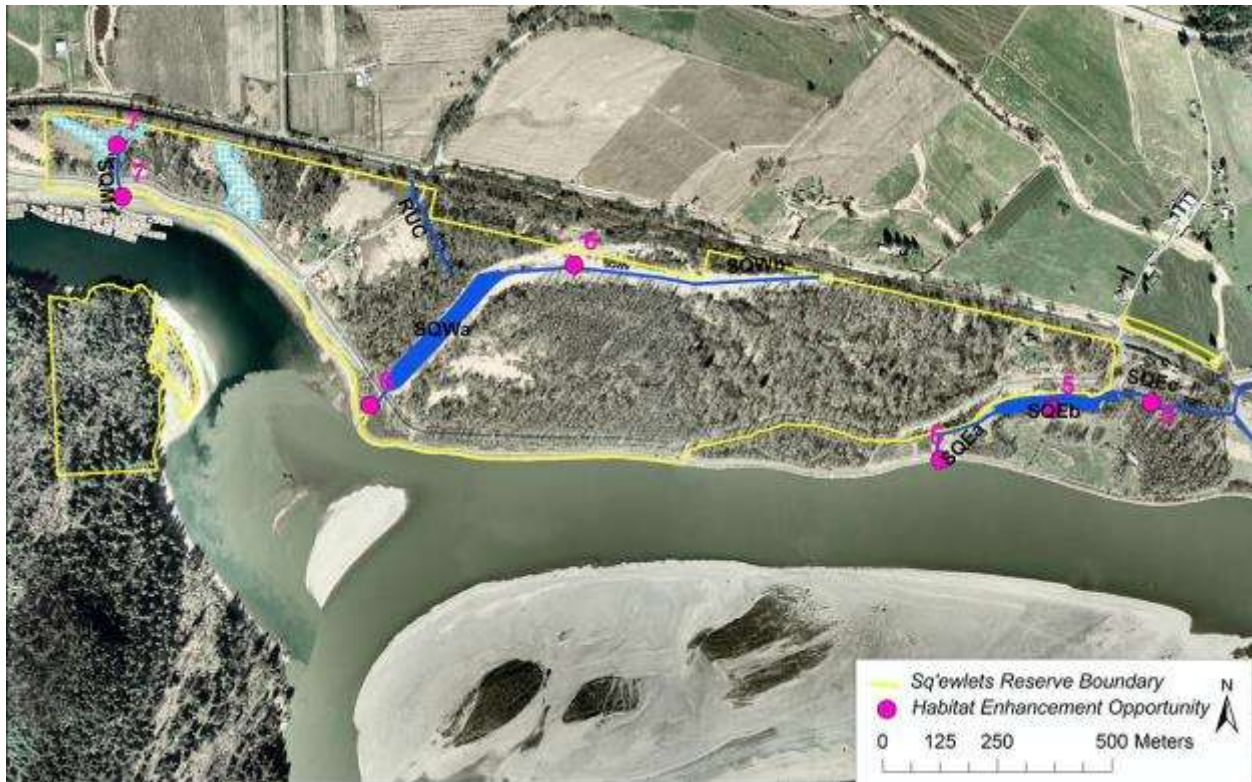
Figure 10: Habitat enhancement opportunities at Sq'ewlets 1 Reserve. Numbers correspond to paragraphs below.

The primary opportunities at Sq'ewlets 1 involve restoring fish access from the Fraser River to the two Sq'ewlets sloughs, and potentially to Sq'ewlets Marsh (Figure 9). The two sloughs have been identified as among the top 20 priority sites in the Fraser Valley for restoring fish access through dikes in the recently initiated 'Resilient Waters' prioritization project funded by a British Columbia Salmon Restoration and Innovation Fund (BC SRIF) grant to Tides Canada. This project is being led by KWL Engineering with Pearson Ecological conducting field assessments. Field work was scheduled to begin in March 2020, but has been postponed due to the Covid-19 pandemic. Following field work, the 20 projects already identified will be prioritized with for implementation over the next 4 years of the BC SRIF mandate.

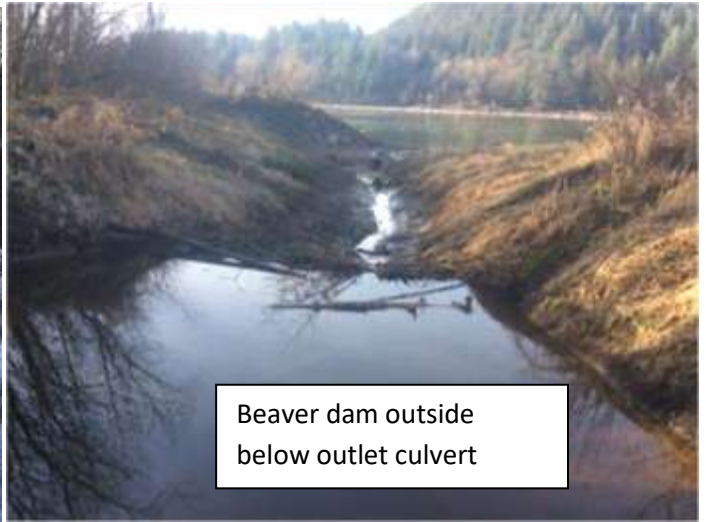
Beaver dam outside below outlet culvert

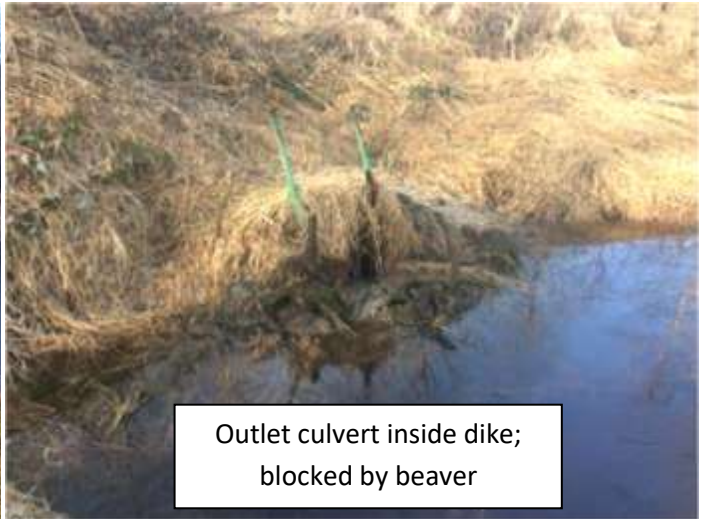
Outlet culvert inside dike; blocked by beaver

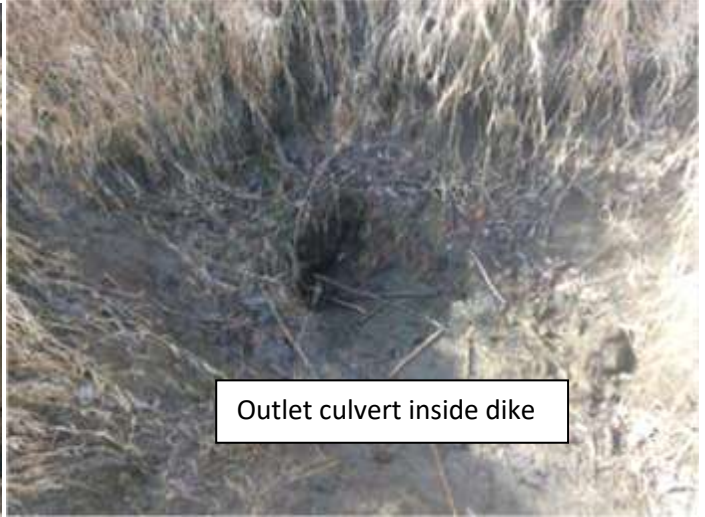
Outlet culvert inside dike

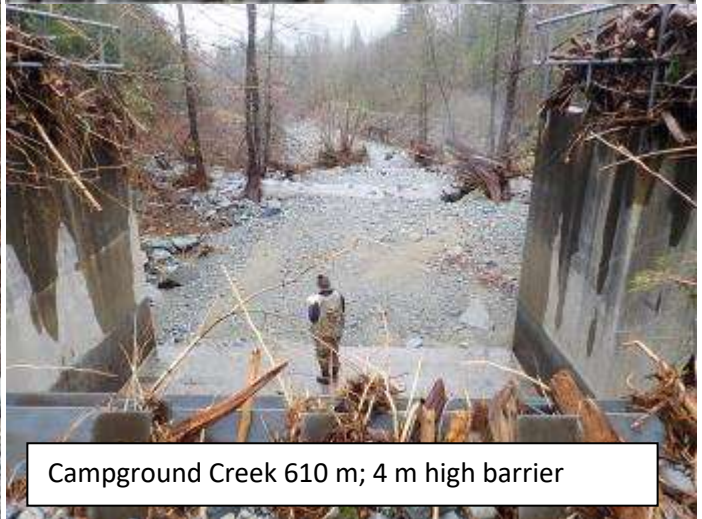
Campground Creek 610 m; 4 m high barrier
