**Project Title: Restoring Salmon Habitat in the Chilliwack/Vedder River Corridor:  
Peach, Street & Salwein Creeks**

**March 30, 2019**

Prepared by:  
Natashia Cox and Rachel Drennan Fraser Valley Watersheds Coalition

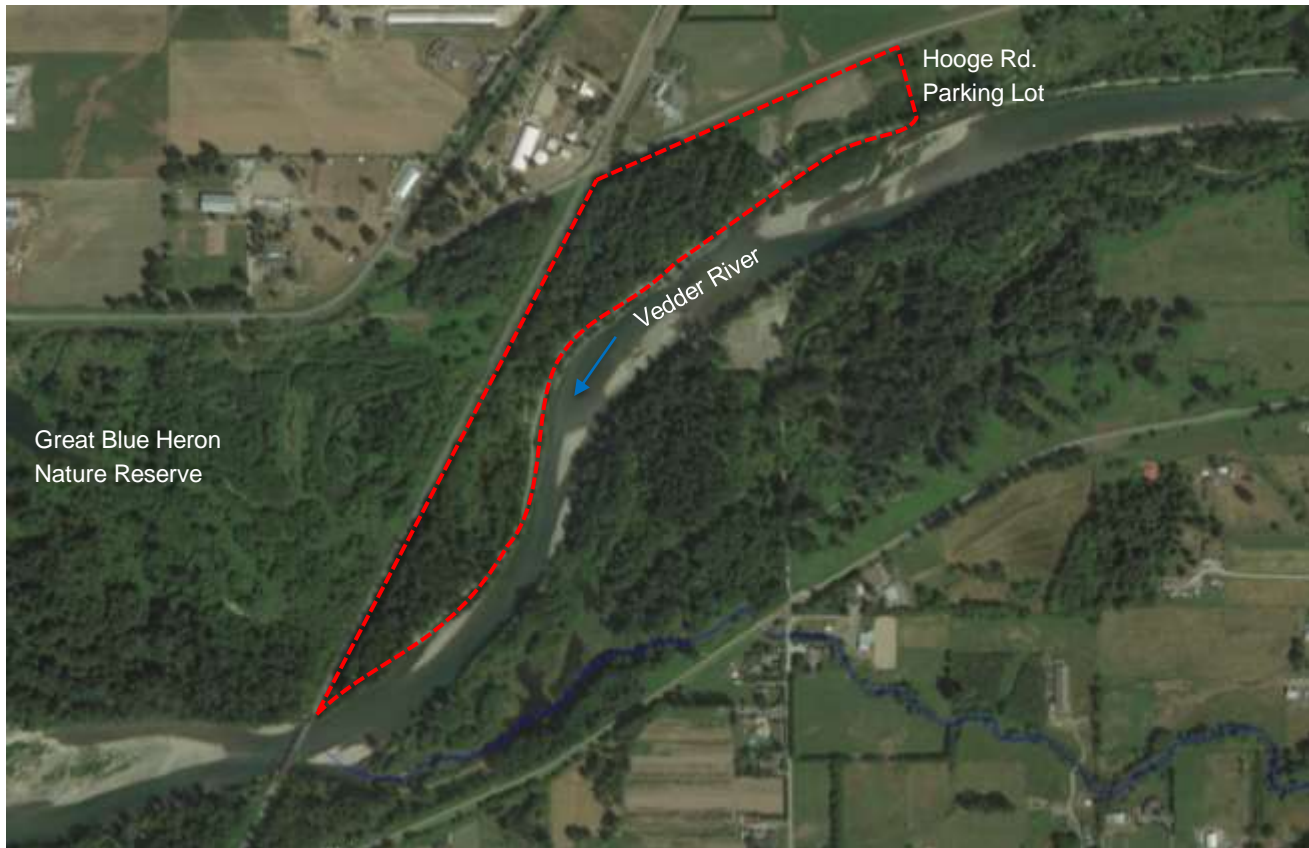
Map 1. Overview of project scope and location, indicated by dashed red line. In relation to the Great Blue Heron Nature Reserve and Hooge Rd. Parking lot, Chilliwack BC.

This phase of the project is located within the Vedder River floodplain on the north side of the River between the Great Blue Heron Nature Reserve and just upstream of Hooge Rd Parking lot, in Chilliwack BC, Map 1.

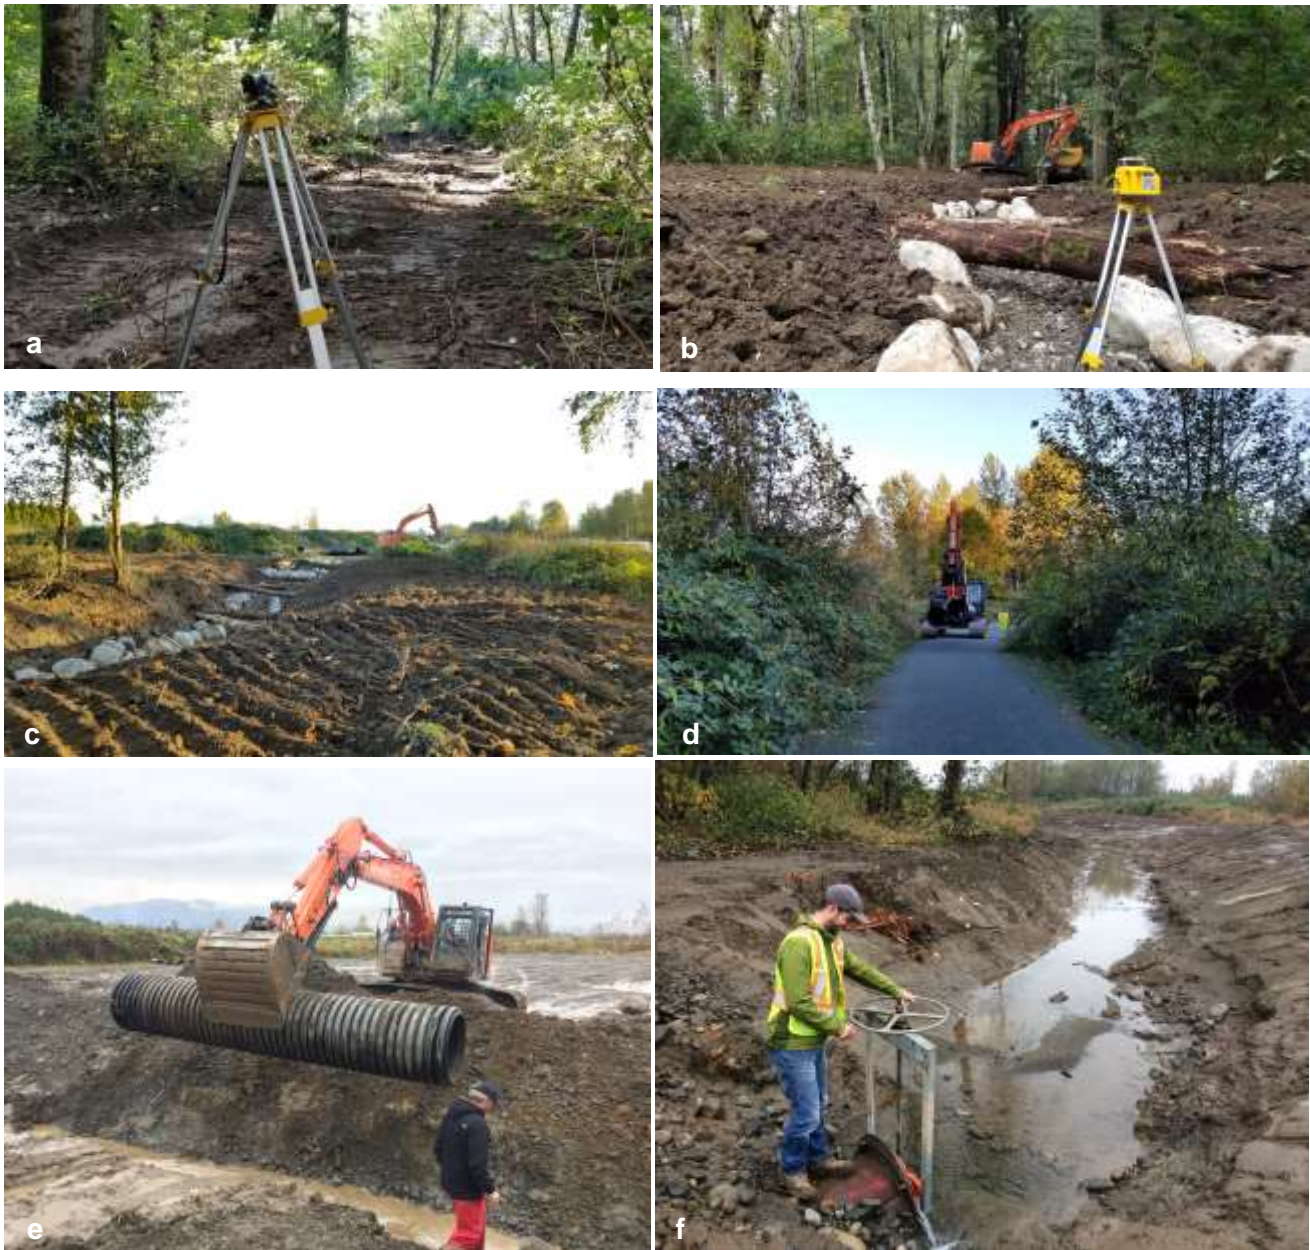
*Figure 1. Photo-documentation of the instream restoration works. A. Alignment roughed out and surveyed. B. Construction of channel alignment, with boulders along bank to protect fine substrate from sloughing. C. Construction along alignment near Hooge Rd parking lot. D. Contracted flagger-mobilizing machine down dike infrastructure, ensuring public safety. E. Installation of PVC pipe to support conveyance of water at Hooge Rd parking lot. F. City staff worker opens the control valve at upper end of Peach- connection channel Nov. 2018.*

Lead by DFO Resource Restoration Unit, construction began in September 2018 to November 2018. Excavators and rock trucks were used to excavate 960 linear meters (1,680 m<sup>2</sup>) of new channel, place bank boulders, install 40 pieces of large wood throughout the channel and install the flanged control slotted intake. This upstream intake connects the increased flows from Peach Creek to the new channel. A total of 5 culverts were installed throughout the approximately 1 km project scope to allow movement of water through the new channel. The steel pipe that connected McFaden pond to the lower downstream end of the channel required on-site welding to seal and connect two pipe lengths.

After the channels were constructed, straw was blown on the exposed soils for erosion control measures. Figure 1, 2, Appendix A. As Built.

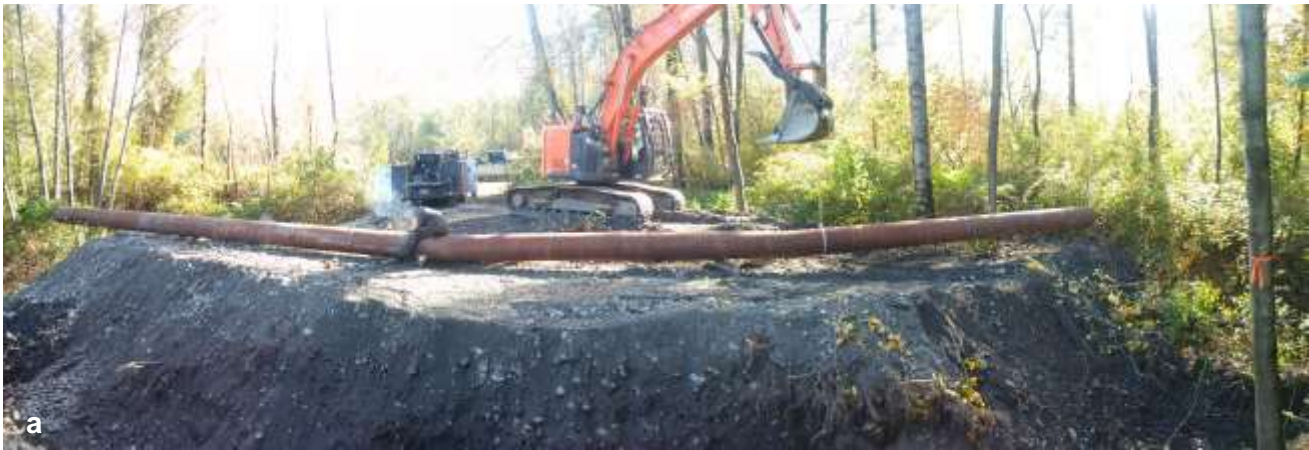
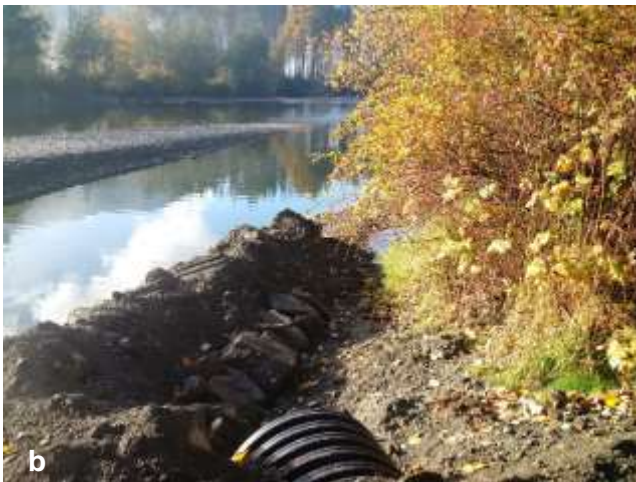
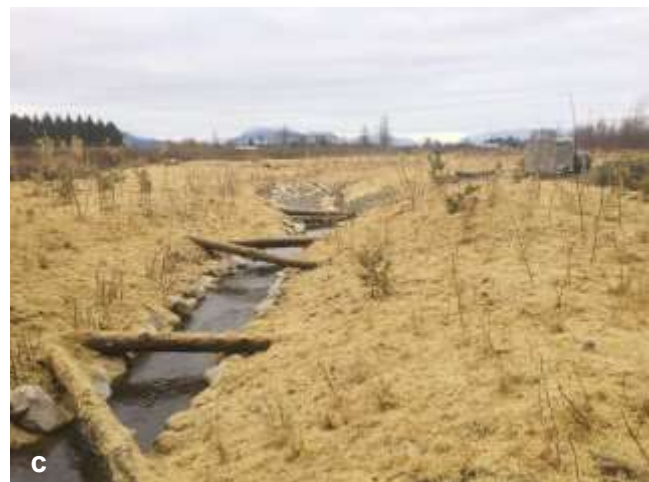
*Figure 2. Photo-documentation of instream restoration. A. Installation of the steel connector pipe required to connect McFaden pond to the new Vedder River outlet channel. B. Outlet channel and PVC pipe. C. Straw spread along the project area after construction for erosion and sediment control measures.*

As part of the design, channel works through Hooge Rd. parking lot had to maintain minimum distances away from the existing dike infrastructure, and consider the drainage requirements of the parking lot (so as to avoid lot run-off into the channel). The outlet channel required the movement of two memorial park benches. To move these (and return them after the outlet culvert was installed) required support from the City of Chilliwack.

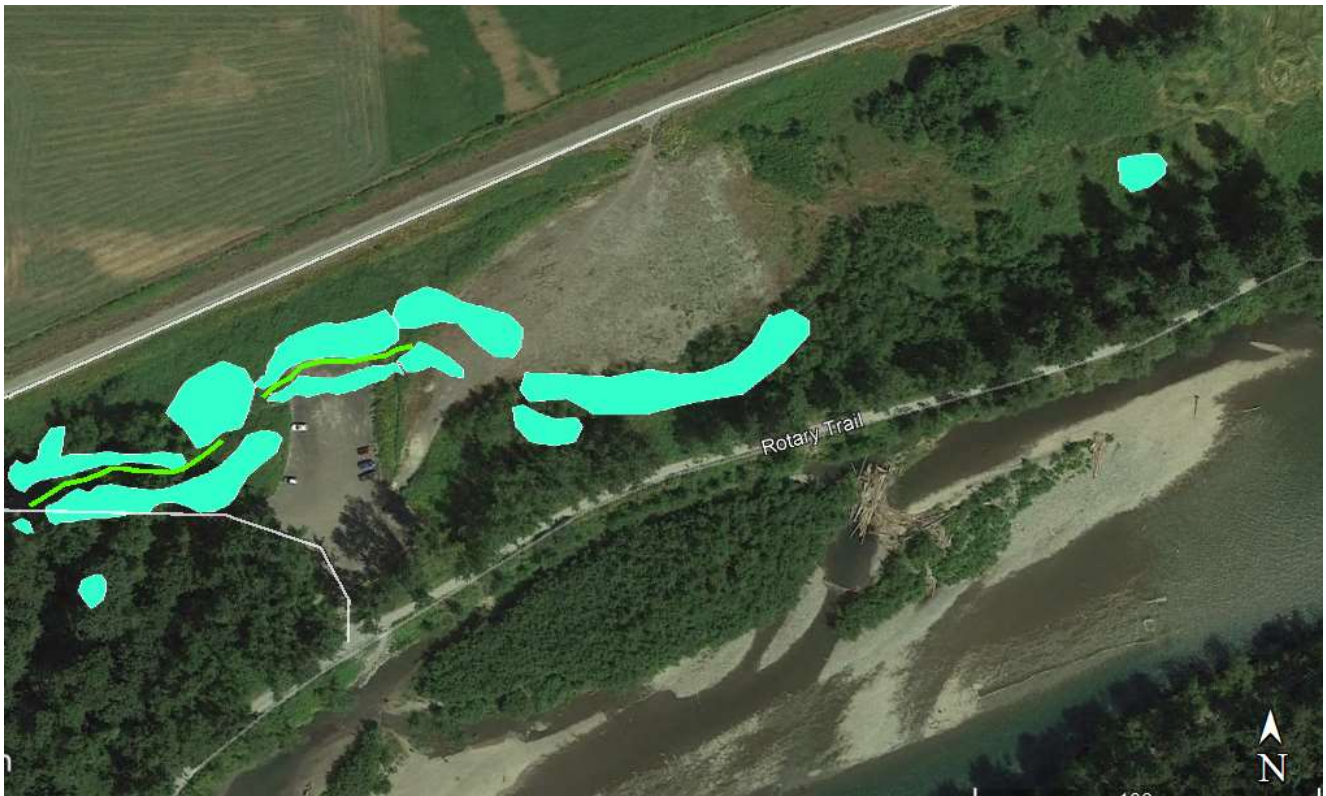
Figure 3 Replanting Area resulting in 3,648m<sup>2</sup>. Turquoise polygons show where potted stock and live stakes are mixed together. Green lines show dense cluster plantings of willow stakes to help shade the waterway and provide leaf litter.

Planting was completed in the fall of 2018 and winter of 2019, by the FVWC field team and community volunteers. A total of 10,870 individual native plant species were hand-dug into 3,648m<sup>2</sup> area to support the newly constructed channel, Table 1, Figure 3. Seeds from native herbaceous plant (species such as small camas (*Camassia quamash*), Nodding onion (*Allium cernuum*), Yarrow (*Achillea millefolium*), and Canadian goldenrod (*Solidago Canadensis*)) were spread along the banks of the channel in areas where the ground was compacted by machine and potted stock could not be installed. The seeds (approximately 100 grams) were mixed with a fine, wet sand and spread by hand over the area.

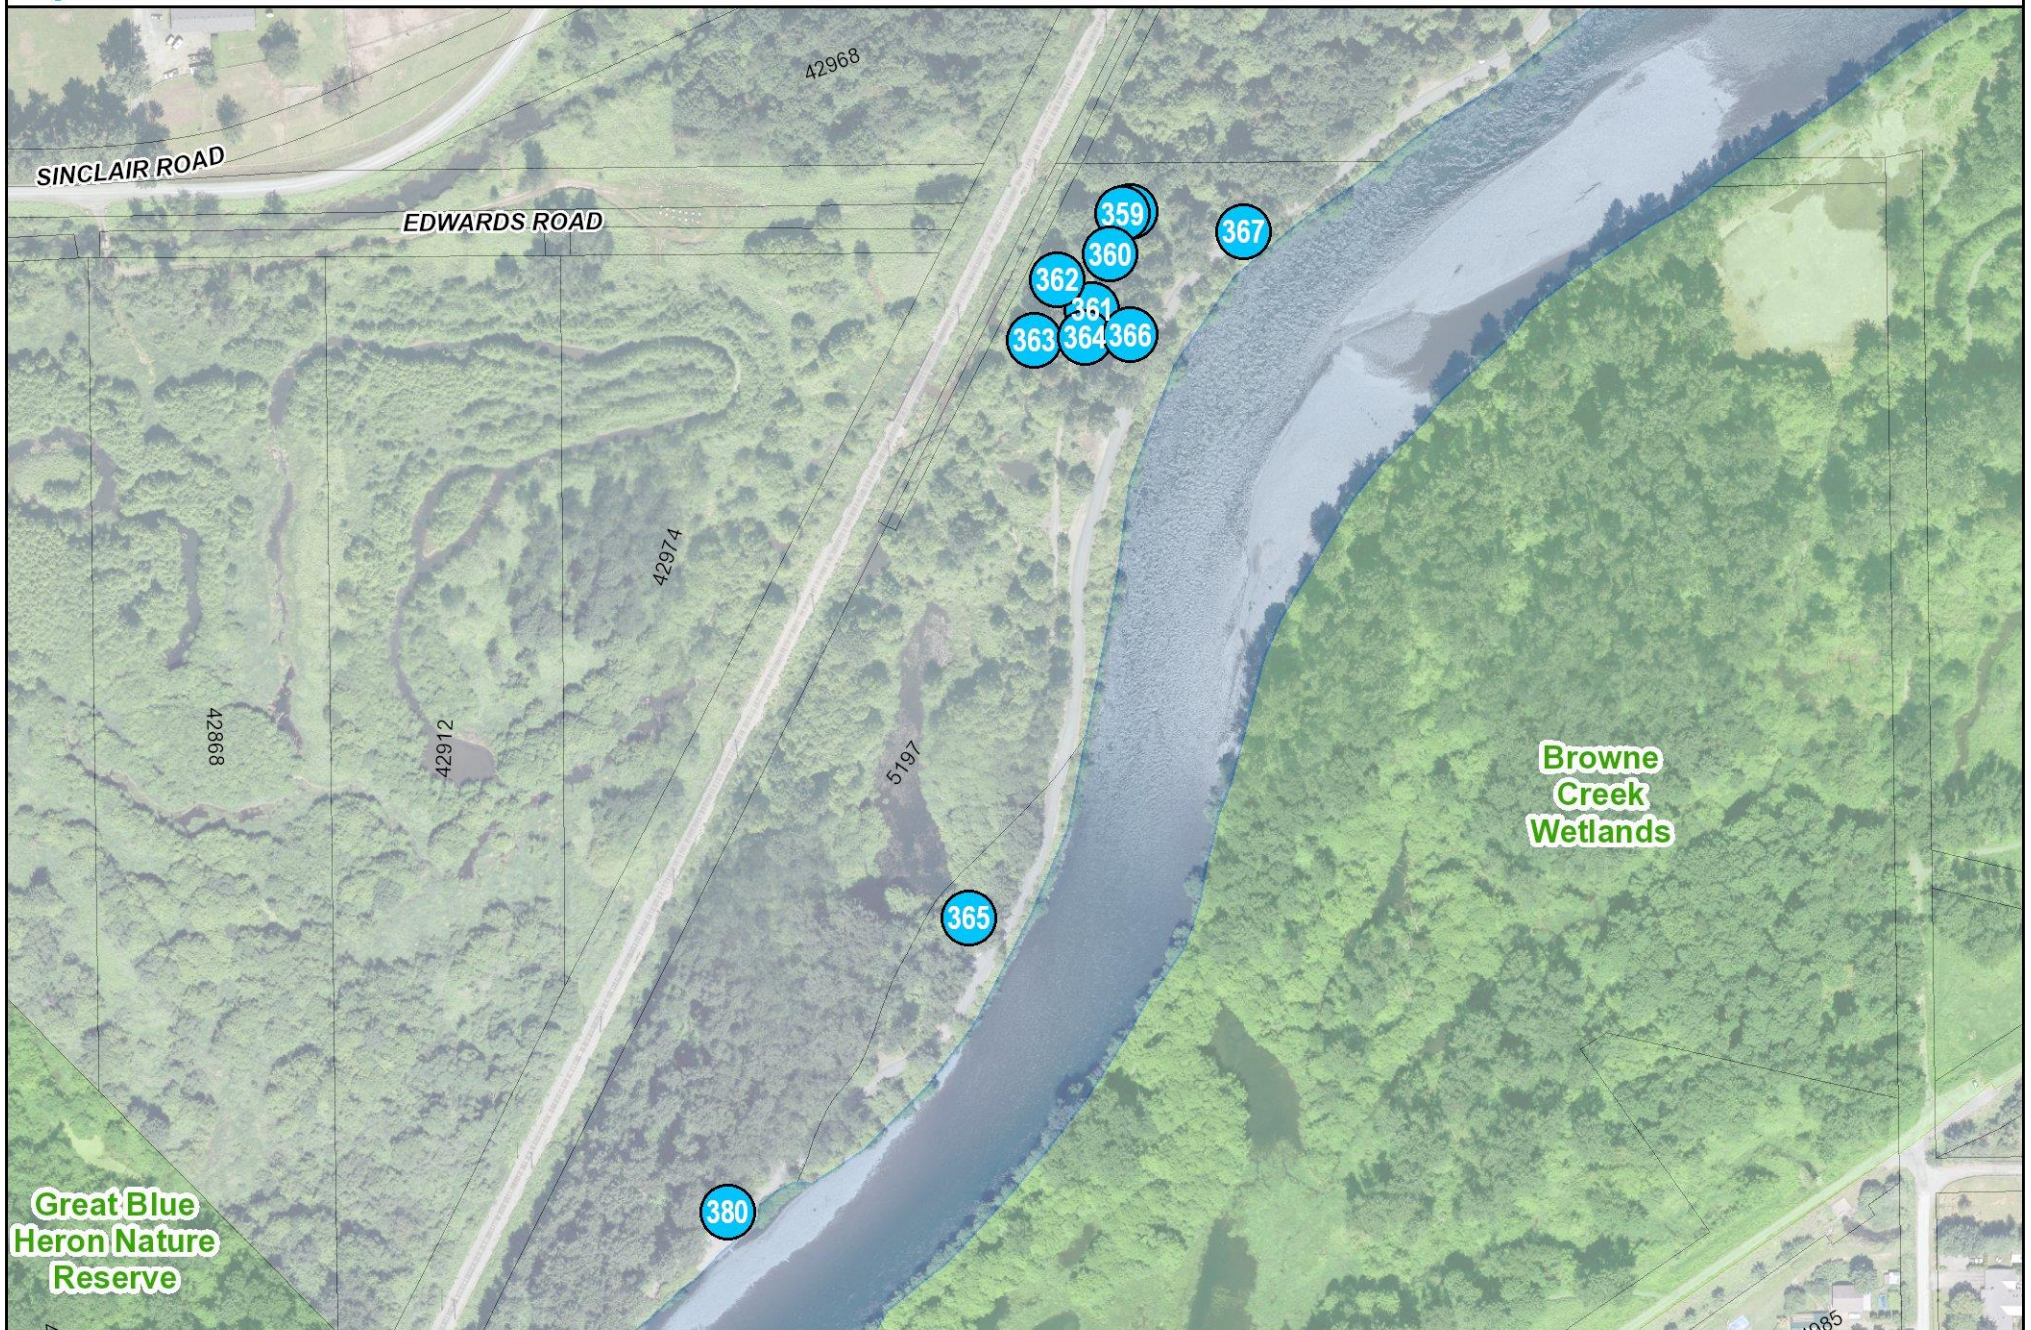
Scale: 1:3,000

Further to the flagging and initial treatment in 2017, the JK sites were gps'ed and uploaded to the City's GIS program in 2018 (see enclosed map). The locations were also treated by foliar application and stem injection by the City's contractor in 2018. Further, City staff also met with FVWC and DFO staff to review the locations, setbacks, and protocols regarding JK before channel excavation commenced. This onsite assessment resulted in the mutually beneficial realignment of a small portion of the channel to avoid contact with a JK patch.

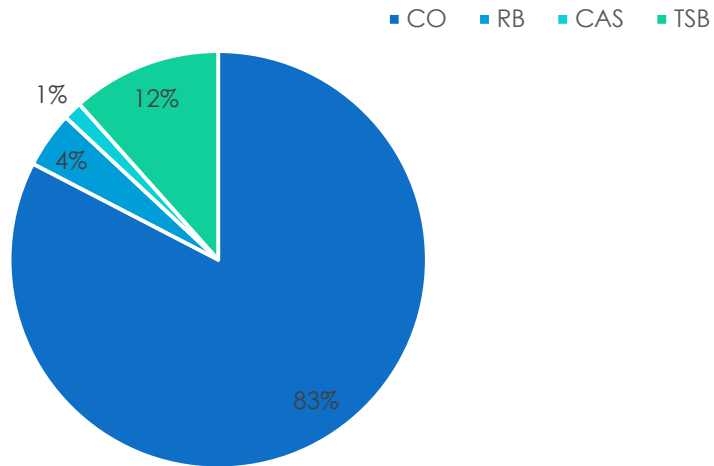
Figure 1. Fish Monitoring by Species - Caught at Peach Creek Feb 20 2019. 83% of fish caught were Coho salmon. 4% of fish caught were Rainbow trout.

Station	Total Fish Caught	CO	RB	CAS	TSB
Peach 1	4	1	3	0	0
Peach 2	10	5	0	0	5
Peach 3	0	0	0	0	0
Peach 4	1	1	0	0	0
Peach 5	1	1	0	0	0
Peach 6	31	30	0	1	0
Peach 7	4	4	0	0	0
Peach 8	11	11	0	0	0
Peach 9	8	4	0	0	4
<b>Totals</b>	<b>70</b>	<b>57</b>	<b>3</b>	<b>1</b>	<b>9</b>
